PROBLEM SUMMARY

Machine Id
AUTOCANE 1A
Component
Gearbox
Fluid
CHEVRON MEROPA 220 (10 GAL)

OIL ANALYSIS REPORT

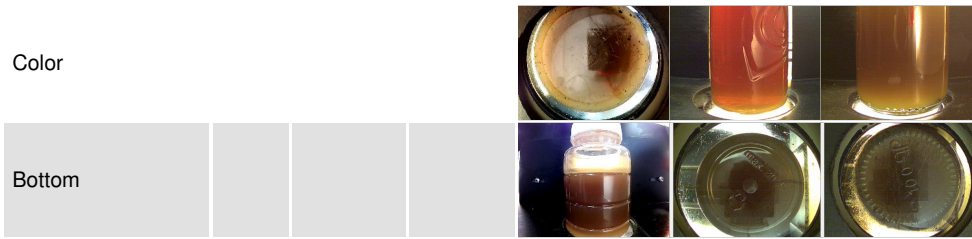
SAMPLE IMAGES	method	limit/base	current	history1	history2
---------------	--------	------------	---------	----------	----------

Appearance is hazy. Free water present. There is a moderate concentration of water present in the oil. There is a moderate amount of visible silt present in the sample.

We advise that you check for the source of water entry. We advise that you follow the water drain-off procedure for this component, and use off-line filtration to improve the cleanliness of the system fluid. We recommend an early resample to monitor this condition. We were unable to perform a particle count due to a high concentration of particles present in this sample. Due to an abnormal test result it is recommended to contact Stauff Corp at (201)-444-7800 for help resolving the issue.
