Area
Recycled Fiber
Machine Id
FILTER
Component
Filter
Fluid
{not provided} (--- GAL)

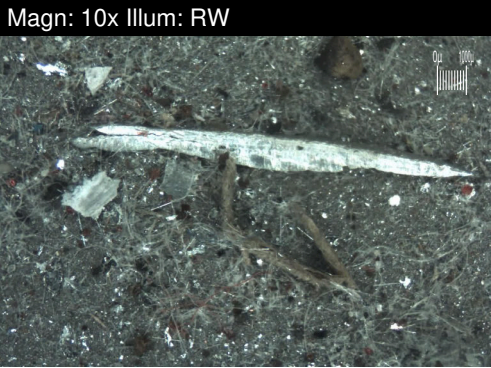
The filter contained no appreciable wear particles. All filter wear levels are normal. filter patch is non-ferrous, image 1 consists of large non-ferrous particle, tested positive for Aluminum (wet chem). Image 2 consists of 10-20 ferrous rolling wear.
