PROBLEM SUMMARY

Machine Id
TURBINA 09 - FRONT BEARING (S/N 101311)
 Component
Grease
 Fluid
KLUBER KLUBERPLEX BEM 41-141 (--- LTR)

GREASE ANALYSIS

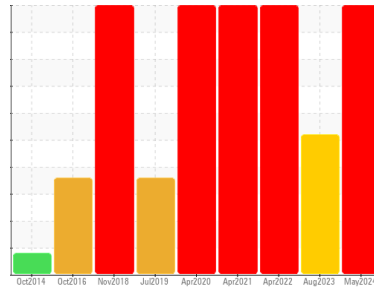
Sample Rating Trend

Sample Status			SEVERE	ABNORMAL	SEVERE
PQ		ASTM D8184 >200	▲ 18861	▲ 17256	▲ 10883
Iron	ppm	ASTM D5185m >250	▲ 11320	▲ 1176	▲ 8886
Chromium	ppm	ASTM D5185m >10	▲ 317	▲ 190	▲ 279

Purge old grease. We recommend an early resample to monitor this condition.

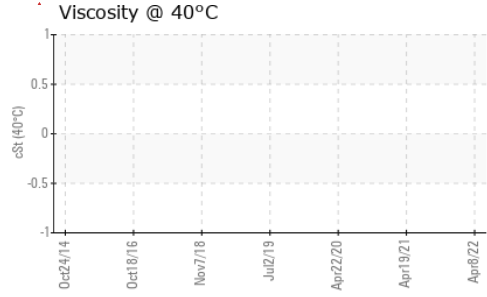
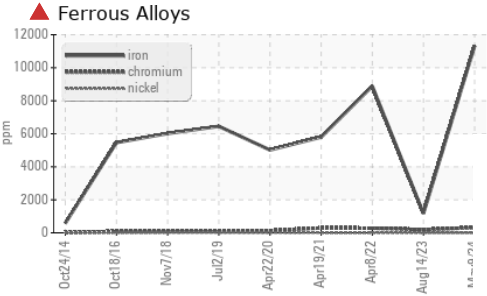
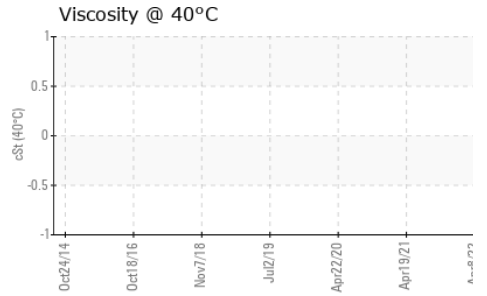
method	limit/base	current	history1	history2
Grease Color	*Visual	yellow	Brown	---	---
Texture	*In-house		Buttery	---	---
NLGI Consistency	NLGI Scale *SKF Method	1	00-0	---	---
