# OIL ANALYSIS REPORT

**LS-043024-01C-200C**

**Chain**

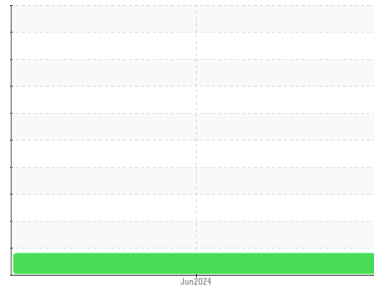
## Sample Rating Trend

**INSOLUBLES**

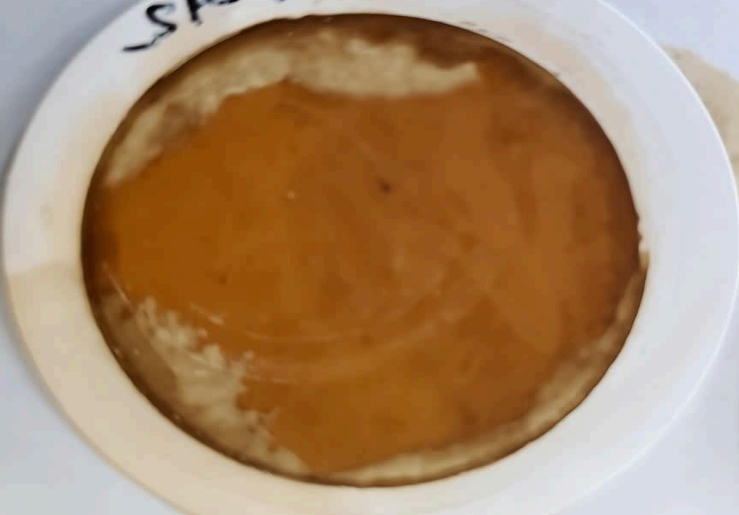
MPC (Varnish Test)

MPC (Membrane Patch Colorimetry) test indicates a high concentration of varnish present.

method	limit/base	current	history1	history2
MPC Varnish Potential	Scale	ASTM D7843	>15 <b>▲ 58</b>	---	---
