# OIL ANALYSIS REPORT

**LS-043024-01C-245C**

**Chain**

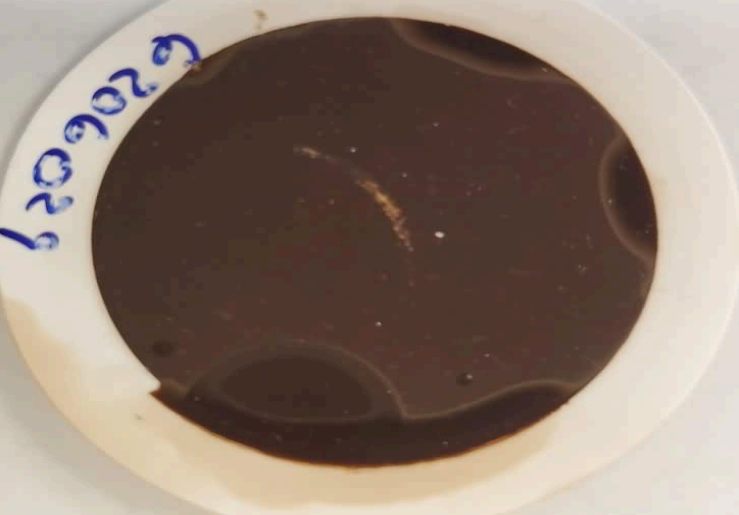
MPC (Varnish Test)

MPC (Membrane Patch Colorimetry) test indicates a high concentration of varnish present.

method	limit/base	current	history1	history2
MPC Varnish Potential	Scale	ASTM D7843	>15	<b>▲ 75</b>	---
