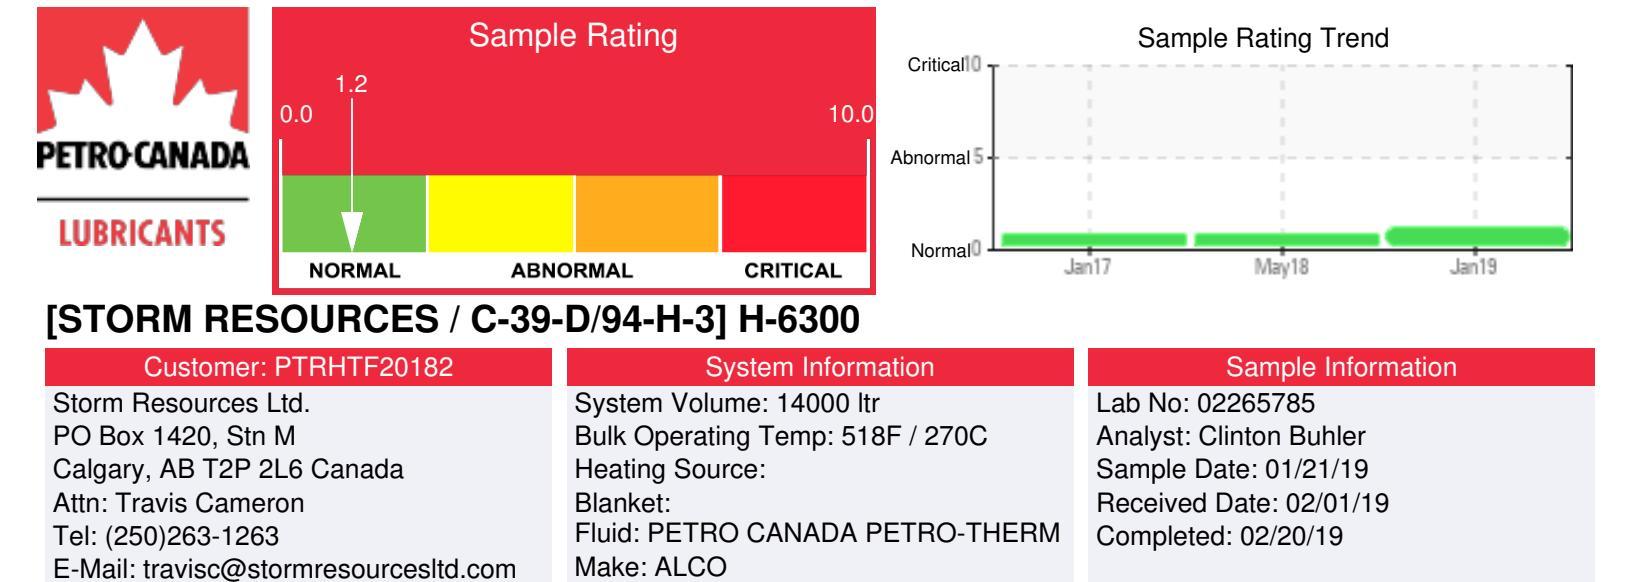
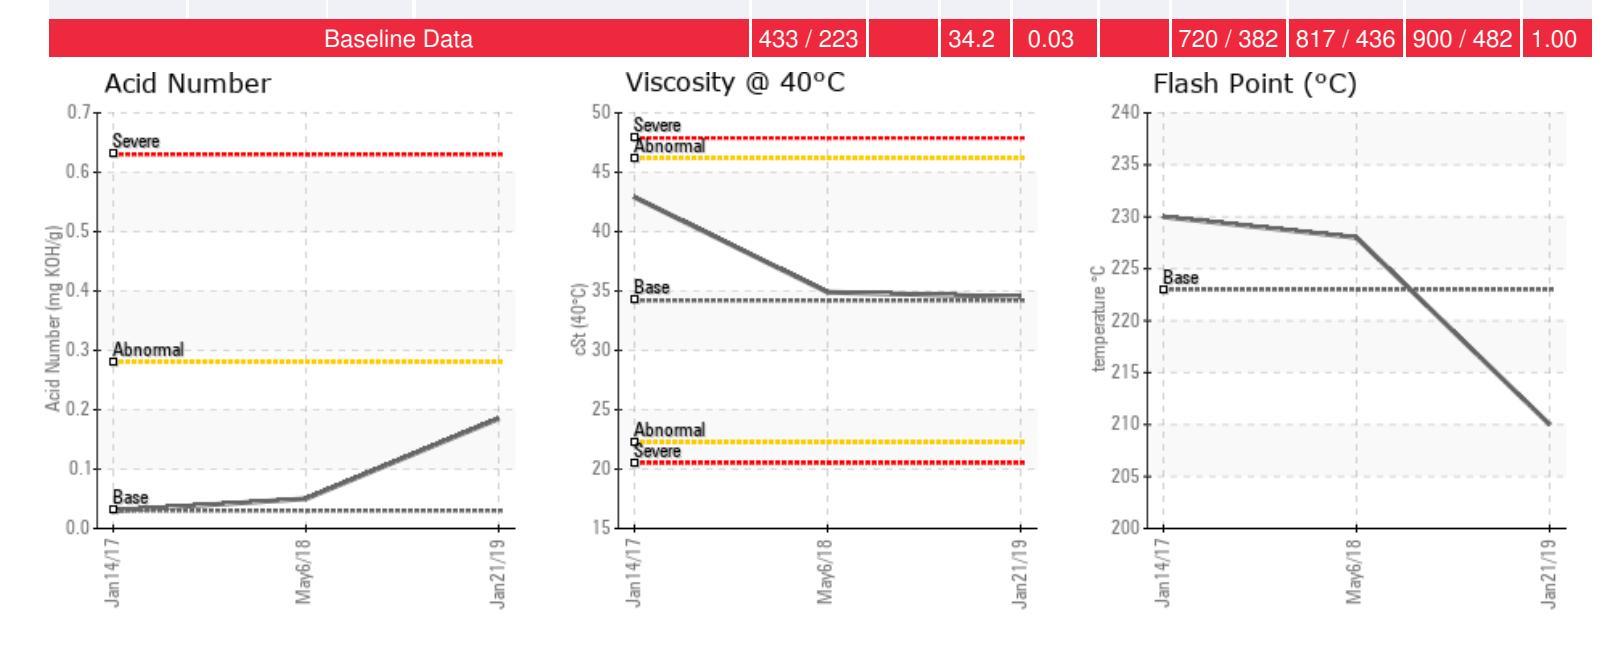
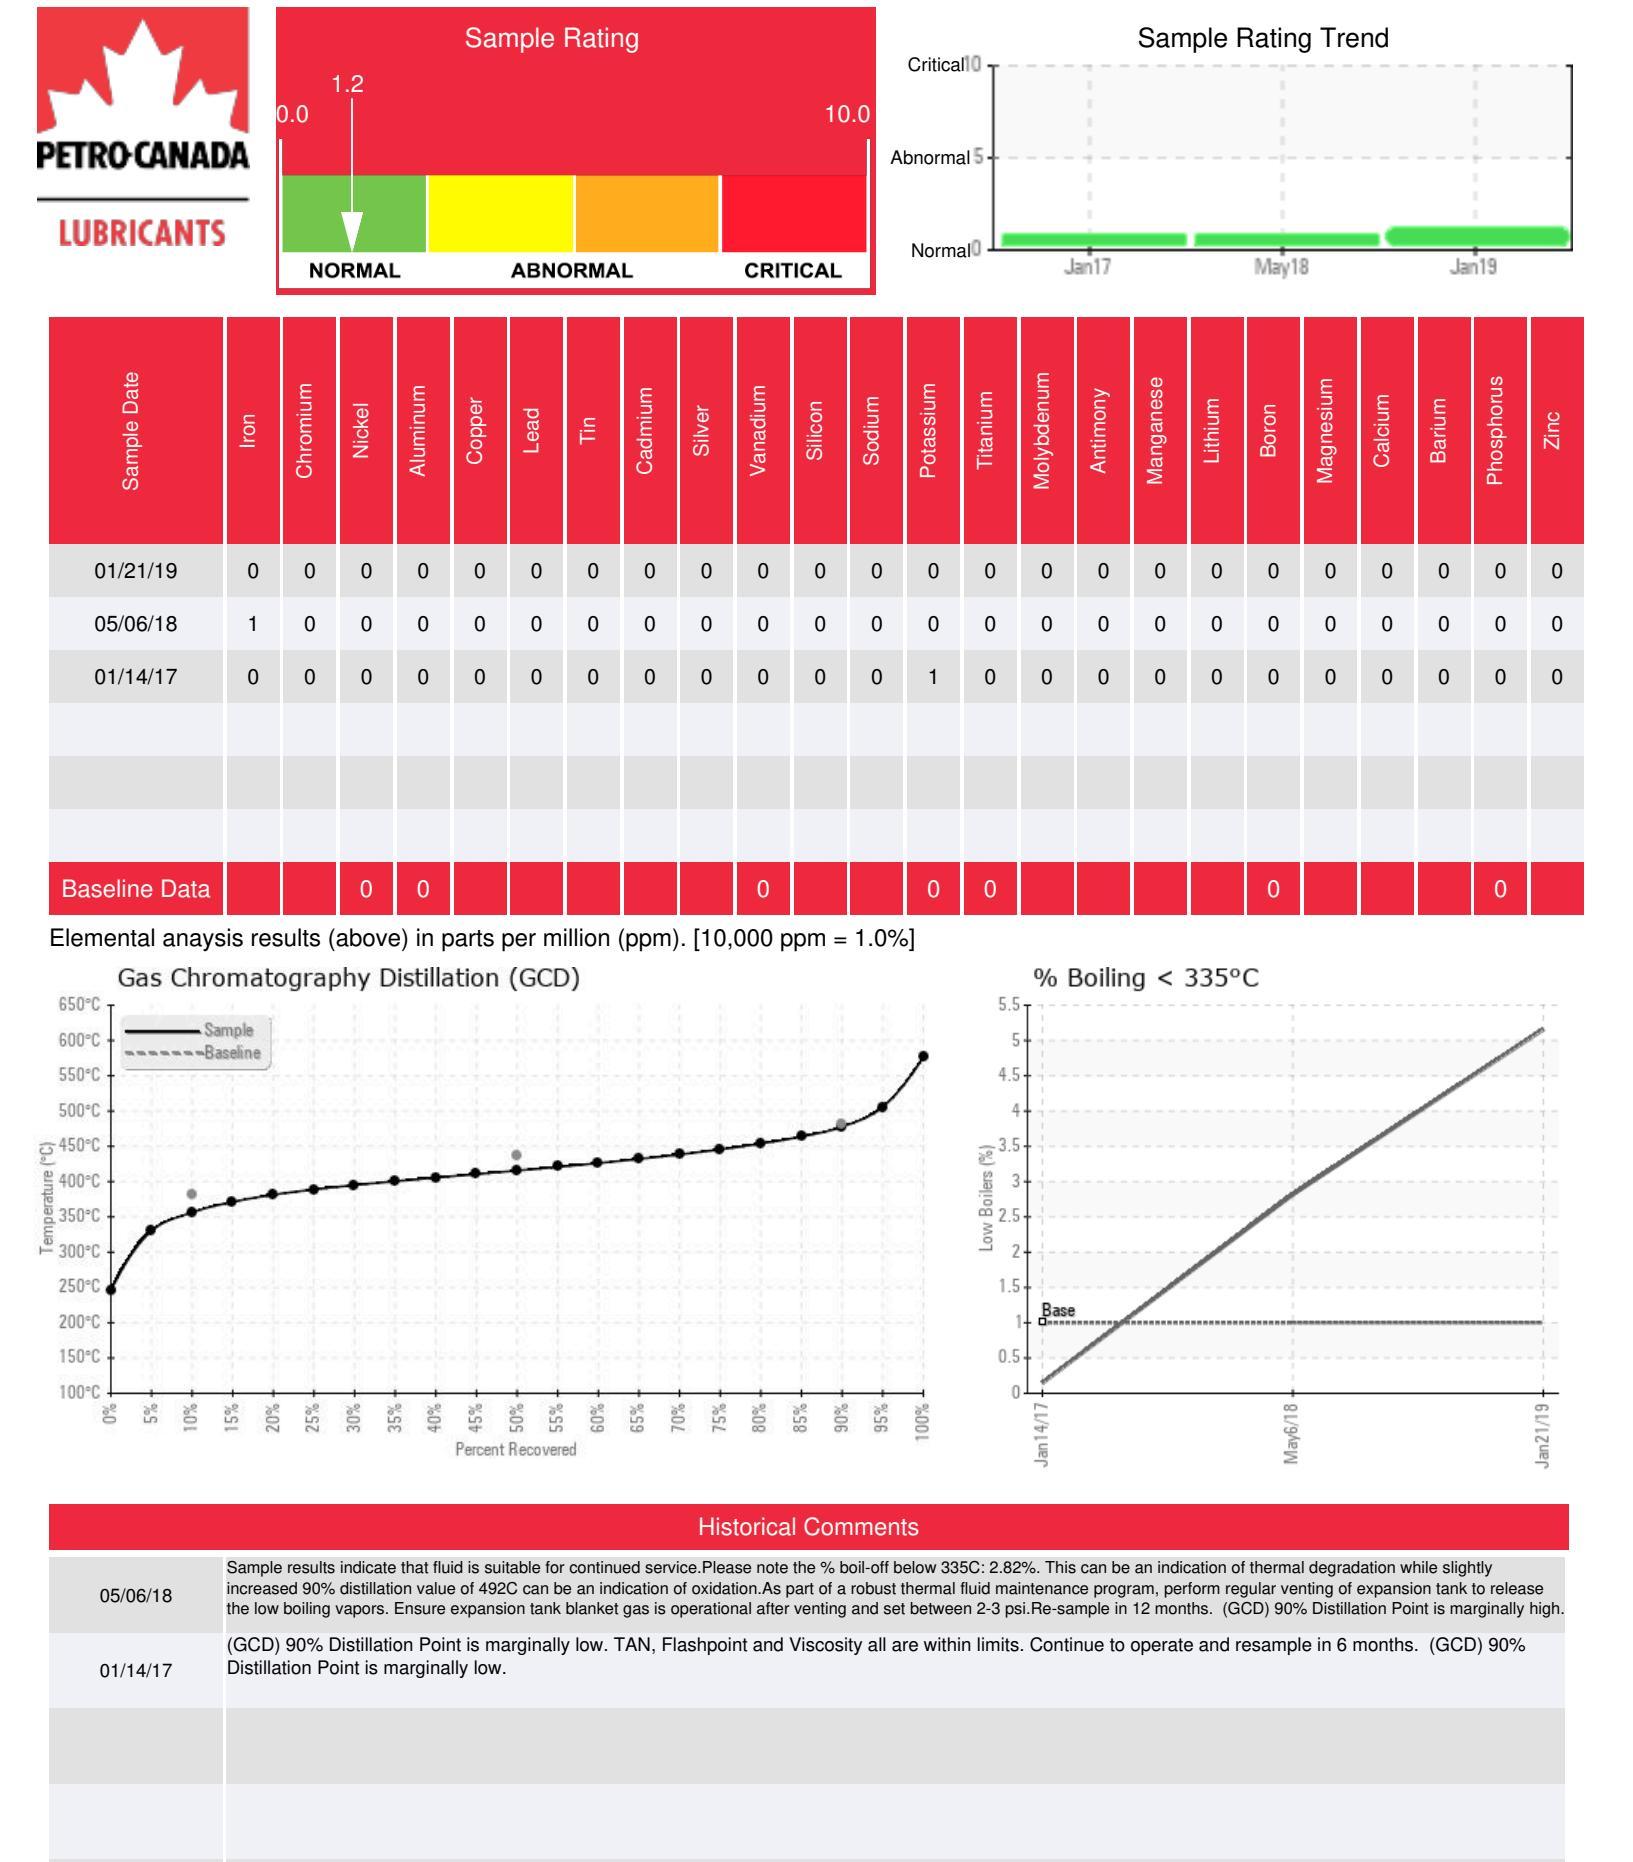
Recommendation: Sample results indicate that the fluid is suitable for continued service.increased % boil-off now at 5.15. This likely indicates thermal degradation or could be related to high blanket gas pressure. Vent expansion tank to remove low boiling vapors from system. If blanket gas is required for proper circulation pump suction head, venting may have to be performed during an outage. Re-sample in 12 months after thorough venting of expansion tank.

Sample Date	Received Date	Fluid Age	Sample Location	Flash Point (COC)	Water (KF)	Viscosity (40°C)	Acid Number	Solids	GCD 10%	GCD 50%	GCD 90%	GCD % < 335°C
	mm/dd/yy			°F/°C	ppm	cSt	mg/KOH/ g	%wt	°F/°C	°F/°C	°F/°C	%
01/21/19	02/01/19	4y		410 / 210	92.4	34.5	0.185	0.055	673 / 356	780 / 416	892 / 478	5.16
05/06/18	05/07/18	13000y		442 / 228	18.4	34.9	0.05	0.043	708 / 376	814 / 434	918 / 492	2.82
01/14/17	02/13/17	4y	SIGHT GLASS	446 / 230	13.5	42.9	0.03	0.062	727 / 386	813 / 434	907 / 486	0.15
