HEAT TRANSFER SYSTEM

Customer: PTRHTF10008	System Information	Sample Information
ARKEMA	System Volume: 3000 gal	Lab No: 02347010
1415 STEELE AVENUE	Bulk Operating Temp: 540F / 282C	Analyst: Yvette Trzcinski
GRAND RAPIDS, MI 49507 USA	Heating Source:	Sample Date: 03/31/20
Attn: RICHARD KOLL	Blanket:	Received Date: 04/01/20
Tel: (616)243-4578	Fluid: PETRO CANADA CALFLO AF	Completed: 04/27/20
E-Mail: richard.koll@arkema.com	Make:	Yvette Trzcinski
		yvette.trzcinski@petrocanadalsp.com

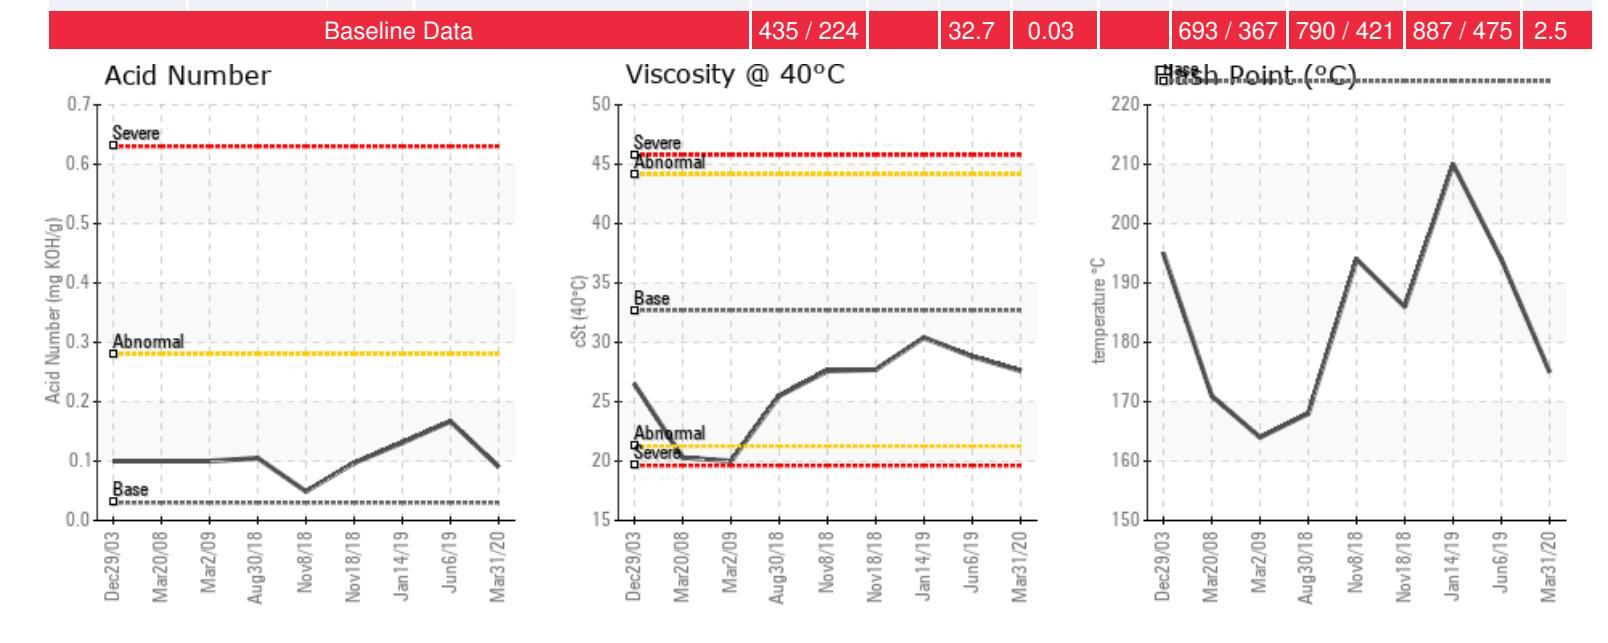
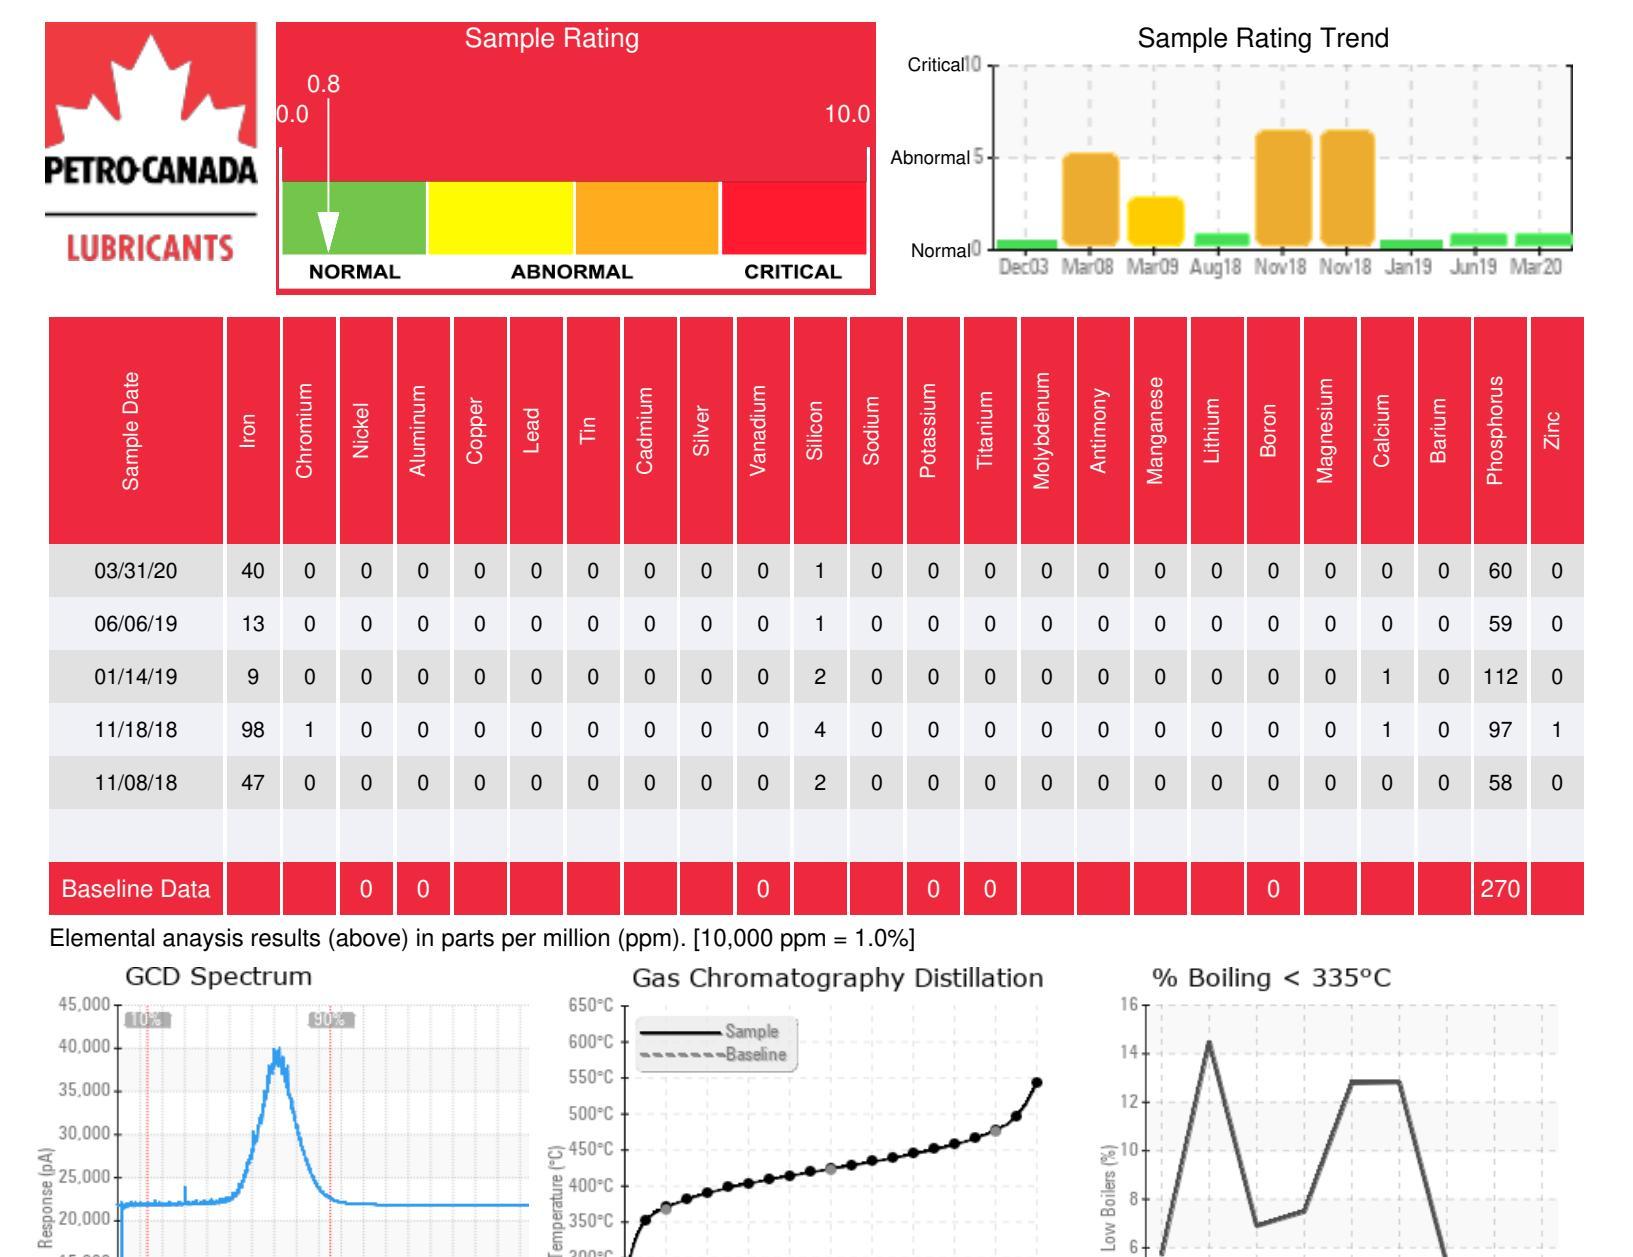
Recommendation: the flash point appears to have dropped slightly as well as the viscosity which is a sign of some thermal degradation but the fluid boiling points and solids are all within normal used fluid specifications resample in 6 months

Comments: COC Flash Point is abnormally low.

06/06/19	Flash point and viscosity have lowered since the last sample indicating thermal degradation of the fluid - venting looks to be removing low boilers due to thermal degradation continue to vent low boilers as normal maintenance practices and resample in 6 months COC Flash Point is marginally low.
01/14/19	This is the baseline sample since the system was changed. Some Thermal cracking could be occurring GCD 90% is marginally low. Resample in 3 months (GCD) 90% Distillation Point is marginally low.
11/18/18	This sample also shows signs of thermal degradation to the system - high level of low boilers that has caused a lower flash point of the fluid and can also lead to pump cavitation overtime a well as coke material that can lead to deposits in the system and increased system fouling. Recommend replacing a portion of the fluid or draining, cleaning and system recharge based on system fouling and deposit build up (GCD) 90% Distillation Point is severely low. (GCD) % < 335°C is abnormally high. (GCD) 10% Distillation Point is abnormally low. (GCD) 50% Distillation Point is marginally low.

11/08/18	Thermal Degradation is occurring in this system causing a reduction in flash point reduction in 90% distillation point – this thermal degradation can lead to the formation of coke material that can foul the system and lead to operation issues and system in efficiency and safety concerns with the fluid over time based on the flash point of the system. Recommend looking at replacing a portion of the system or the entire system. Depending on deposits a cleaning of the system might be required (GCD) 90% Distillation Point is severely low. (GCD) 50% Distillation Point is marginally low.
