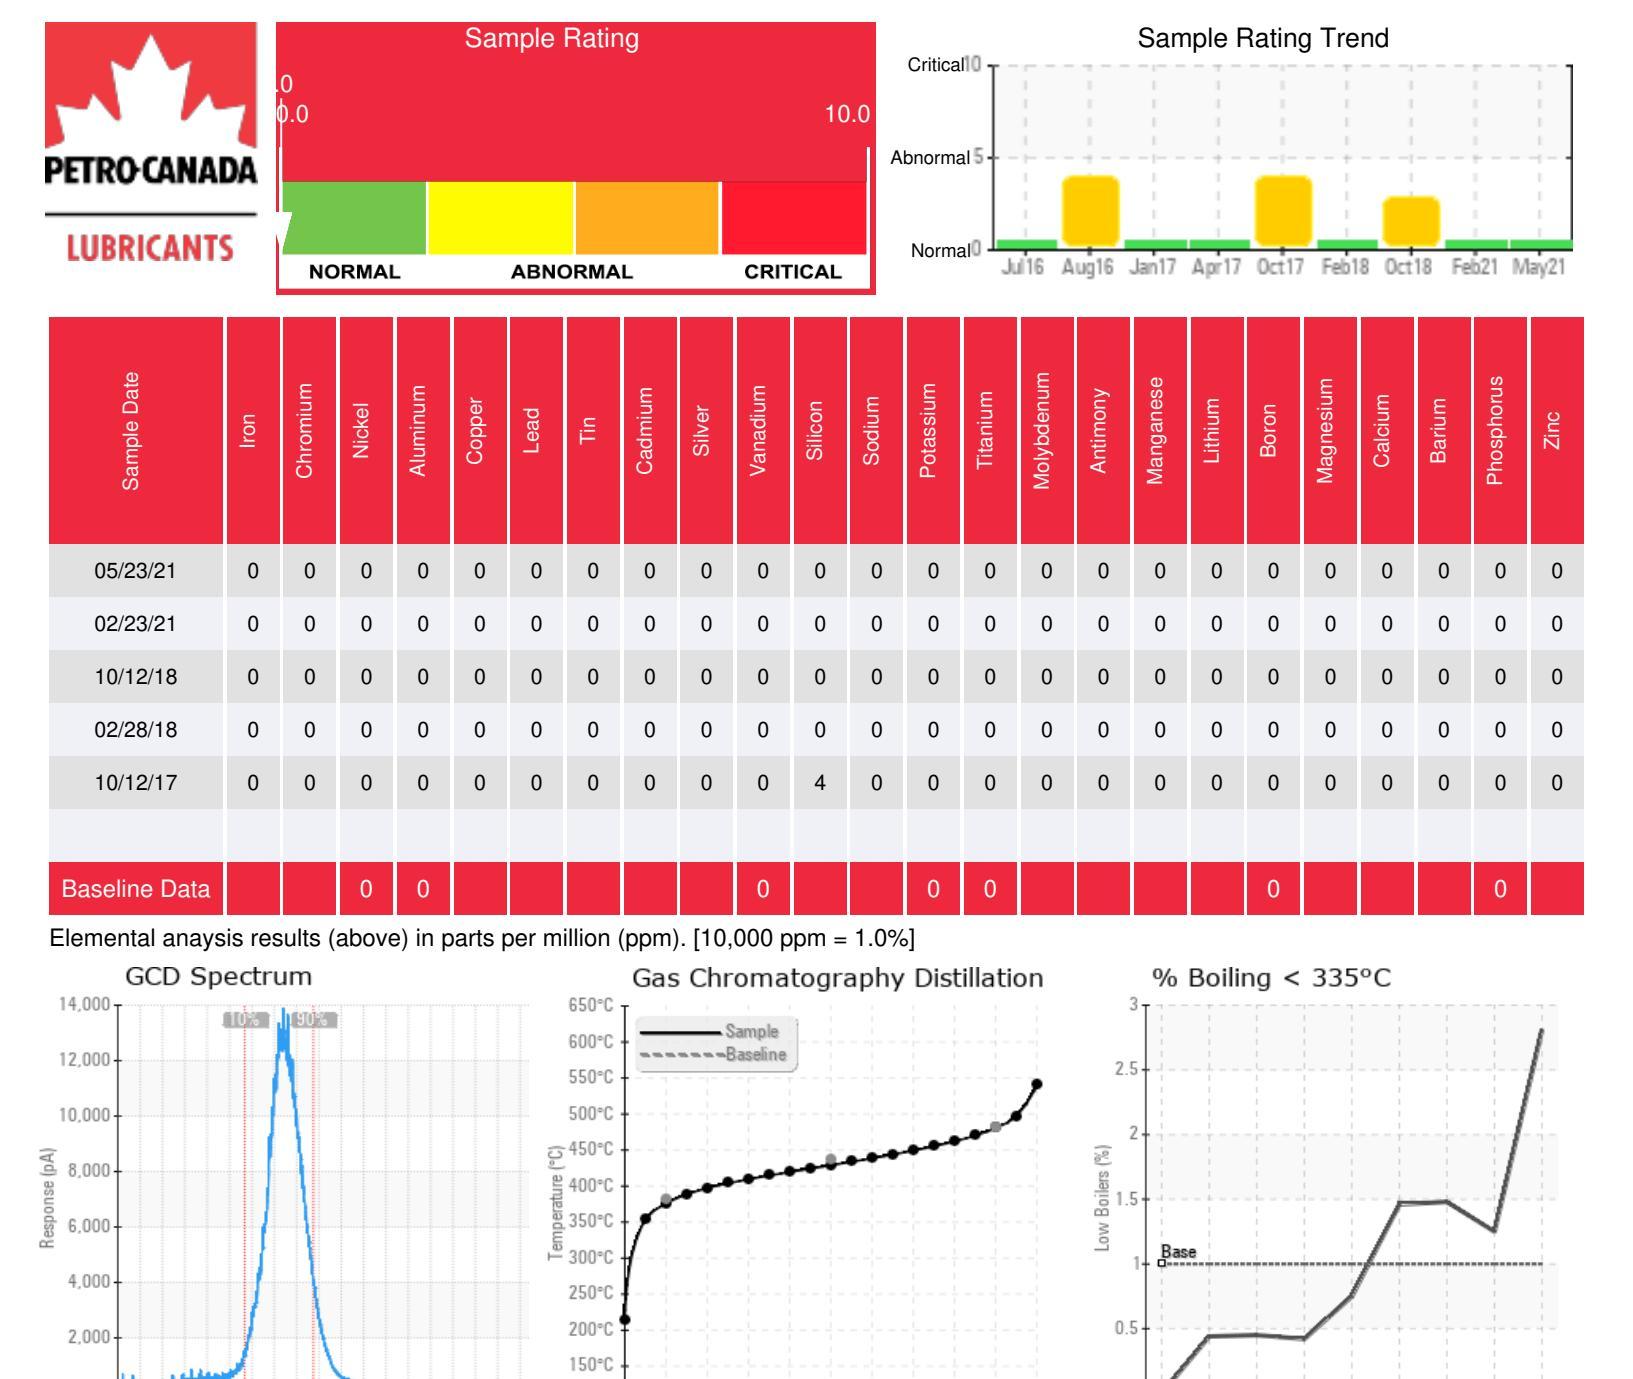
Sample results indicate that the fluid is in suitable condition for continued service. Please re-sample in 12 months

It is understood that there was recently a condensate leak into the HTF system. This may explain the reduced flash point. A reduced flash point can be a safety concern. Following all safety protocol, venting of the low boiling vapors will help restore the flashpoint level to acceptable levels. Blanket gas cannot be in service during venting. Investigate if blanket gas pressure of 210 kpa is required for circulating pump suction head. It so, further investigation into venting is needed. Increased Acid Number generally, sweetening is recommended around an Acid Number of 0.4. In this case, please plan to re-sample system in 6 months once all condensate has been safely removed and the Acid Number can be re-evaluated. COC Flash Point is severely low. Acid Number (AN) is abnormally high.

Sample results indicate that the fluid is suitable for continued service and has improved since last sample as both water and total Acid Number have reduced significantly. The percentage boil off <335C has increased from 0.75 to 1.46 and there has been a slight reduction in flash point. This can indicate possible thermal

degradation or contamination.Consider regular venting of the expansion tank after which time the blanket gas is turned back on.Re-sample in 6-12 months. Water contamination can be a result of the expansion tank being exposed to precipitation. Slight increase in silicon (dirt/dust) may support this. Ensure points of ingression are sealed. Also confirm that sample was not drawn from a dead leg. Please always ensure a thorough purge before drawing sample. Allow water to boil off from expansion tank before putting blanket gas back into use. Aside from the water level in the oil, sample results indicate that the fluid is fit for continued service. Once water contamination has been vented and resolved, re-sample system in 6 months. Water contamination levels are
