Customer: PTRHTF20158	System Information	Sample Information
BONAVISTA ENERGY	System Volume: 14000 ltr	Lab No: 02437559
16-11-54-15-W5	Bulk Operating Temp: 392F / 200C	Analyst: Clinton Buhler
PEERS, AB T0E 1W0 Canada	Heating Source:	Sample Date: 07/17/21
Attn: Dan Duriez	Blanket:	Received Date: 08/09/21
Tel: (780)728-3552	Fluid: PETRO CANADA PETRO-THERM	Completed: 08/12/21
E-Mail:	Make:	Clinton Buhler
dan.duriez@bonavistaenergy.com		Clinton.Buhler@hollyfrontier.com

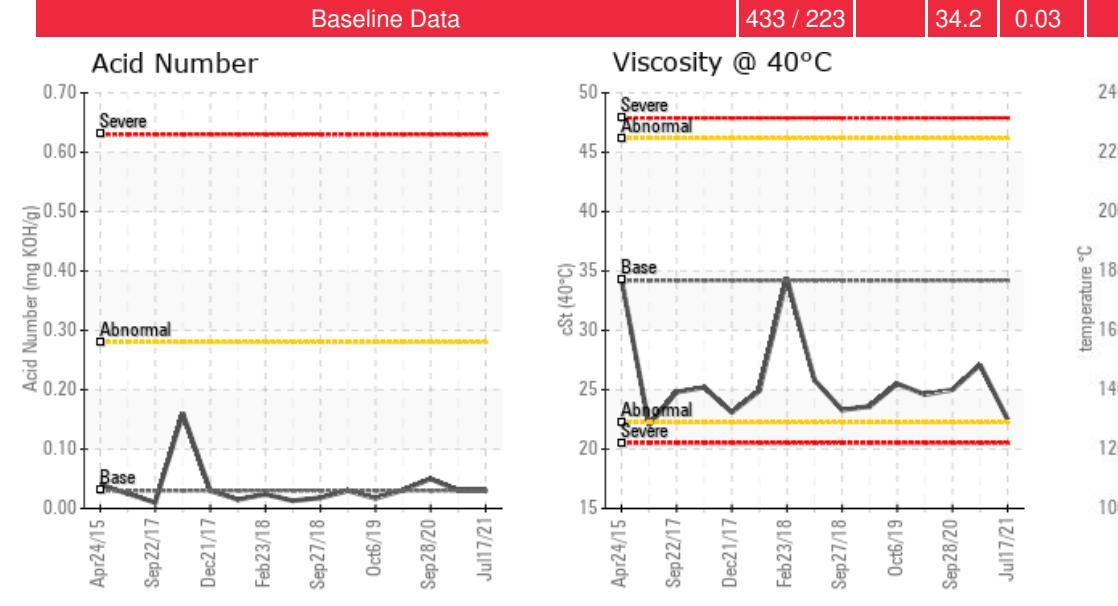
Flash Point (°C)

04/05/21	sample results indicate a slight improvement since the last sample. Further venting of the system is required as there is still >7% of low boiling vapors, low fluid viscosity and reduced fluid flash point This may be associated to thermal degradation, contamination with process fluids or potentially from a high blanket gas pressure. Please increase venting regime to improve the parameters mentioned above. Please check and record what the expansion tank blanket pressure is set at as this may have a bearing on the dilution of the heating fluid. Please include this information, as well as time on oil, on the next fluid sample that is submitted. After thorough venting of system over the course of several weeks, please re-sample in 6 months
09/28/20	The condition of the fluid has improved compared with the previous analysis. This indicates proper operation of the venting system. Flash Point is still too low however has improved since last sample. Viscosity is low. These are signs of thermal degradation of the fluid. This degradation is however not excessive judging from thePentane Insoluble (solids) content which is low and has been stable over the past two years. The fluid is suitable for further use.Please re-sample in 6 months. COC Flash Point is severely low. (GCD) % < 335°C is marginally high. (GCD) 10% Distillation Point is marginally low.

03/14/20	The condition of the fluid has improved compared with the previous analysis. The low boiler vapor content (%<335C.) is close to that of the fresh fluid. This indicates proper operation of the venting system. Flash Point is still too low. Viscosity is low. These are signs of thermal degradation of the fluid. This degradation is however not excessive judging from the Pentane Insoluble (solids) content which is low and has been stable over the past two years. The fluid is suitable for further use. Please re-sample in 6 months. COC Flash Point is severely low. (GCD) 90% Distillation Point is marginally high.
10/06/19	The fluid is in a good condition and suitable for further use. There are still indications of thermal degradation. These are: Low viscosity, Flash Point, 10% GCD temperature and elevated low boiler vapor content (GCD <335C = 5.31%) Although the condition of the fluid has improved compared with the March 2019 sample, it is important to keep venting off the low boiler vapors. Flash Point should be at a minimum of 150C.Service life of the fluid is listed as 0 years. Has the fluid fill been changed since March or is this a mistake ? Please make sure to list fluid service life when taking the next sample which is recommended to do 6 months from now. COC Flash Point is severely low. (GCD) 90% Distillation Point is marginally high.

Recommendation: Sample results indicate continued improvement in low boiling vapor content although fluid viscosity has reduced. Continue venting of expansion tank to further reduce low boiling vapor content. Please re-sample in 6 months
