Machine Id  
**SEW EURODRIVE 24**

Component  
**Port Gearbox**  
Fluid

# OIL ANALYSIS REPORT

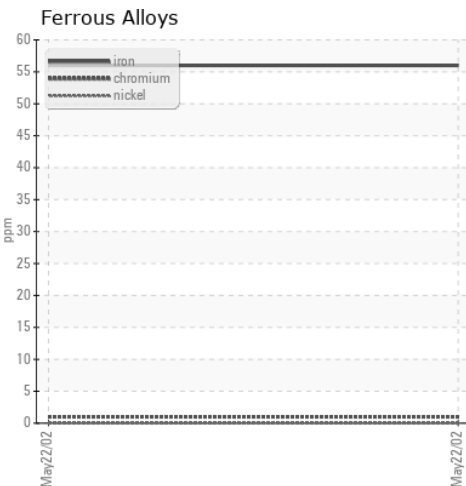
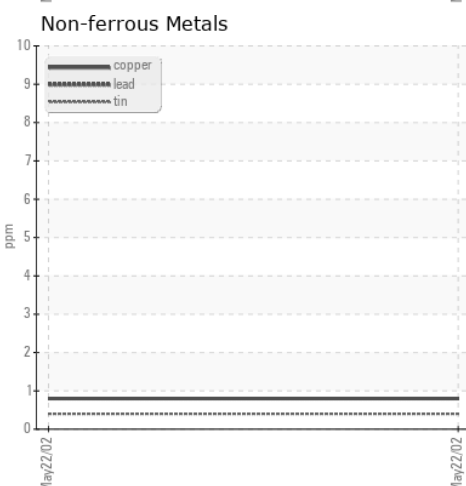
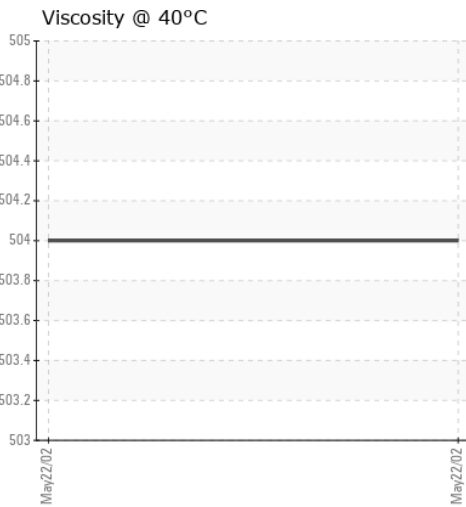
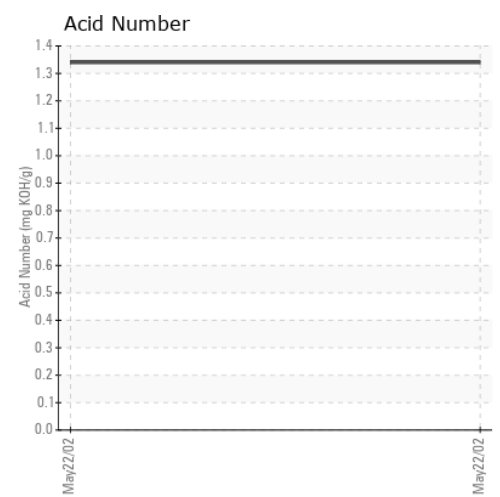
## GRAPHS

All component wear rates are normal.

There is no indication of any contamination in the component.

The condition of oil is suitable for further service.

Resample at the next service interval to monitor.
