Machine Id
SEW EURODRIVE 25
Component
Port Gearbox
Fluid

OIL ANALYSIS REPORT

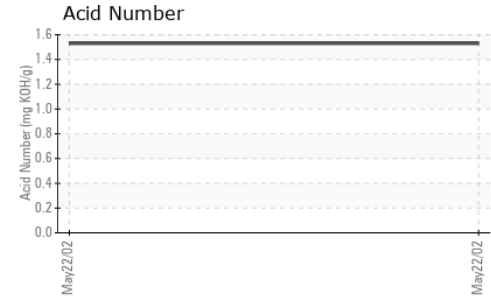
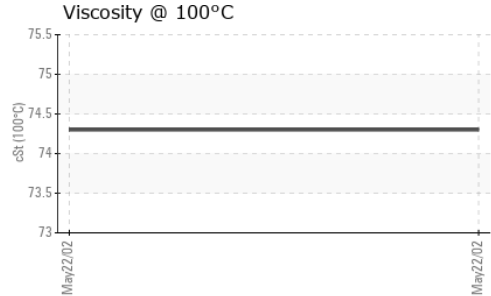
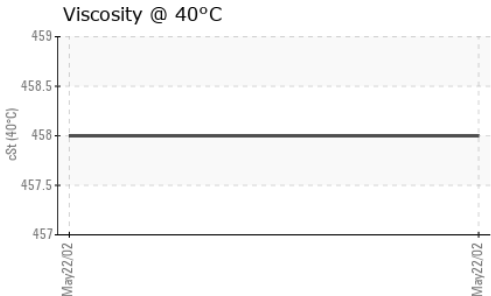
GRAPHS

All component wear rates are normal.

There is no indication of any contamination in the component.

The condition of oil is suitable for further service.
The viscosity index is 243.

Resample at the next service interval to monitor.
Please note that this is a corrected copy.
