# PROBLEM SUMMARY

Area  
**[450162574]**  
Machine Id  
**EXTRUDED GREASE**

Component  
**Grease**  
Fluid  
**PETRO CANADA PRECISION SYNTHETIC (--- GAL)**

# GREASE ANALYSIS

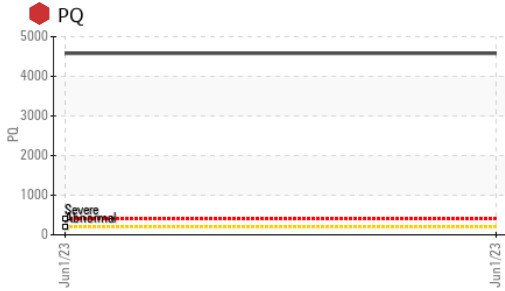
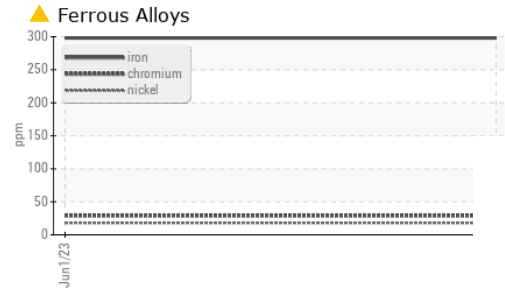
PQ levels are severe. Chromium, iron and nickel ppm levels are abnormal. The very high ferrous density (PQ) index indicates that severe wear is occurring.

Grease consistency has changed by 3 NLGI grades from NLGI 1 to 4. The grease is no longer serviceable as a result of the abnormal and/or severe wear.

High concentration of visible dirt/debris present in the grease.

SAMPLE IMAGES	method	limit/base	current	history 1	history 2
Color				no image	no image
Bottom				no image	no image
PrtFilter				no image	no image

We advise that you check all areas where contaminants can enter the system. We recommend that you re-grease the component if this has not already been done. We advise that you perform a filter service, and use off-line filtration to improve the cleanliness of the system fluid. We recommend an early resample to monitor this condition. The fluid was not specified, however, a fluid match indicates that this fluid is PETRO CANADA PRECISION SYNTHETIC. Please confirm. We suspect that the abnormal contaminant(s) is the result of incorrect sampling technique. **DISCLAIMER:** Interpretation of results is based on the sample as received from the customer. The condition of the sample and the method of sampling cannot be verified.
