OIL ANALYSIS REPORT

Laboratory : WearCheck - C8-1175 Appleby Line, Burlington, ON L7L 5H9
Sample No. : PC0080587
Lab Number : **02618075**
Unique Number : 5735185
Test Package : IND 2 (Additional Tests: KV100, TAN Man, VI)

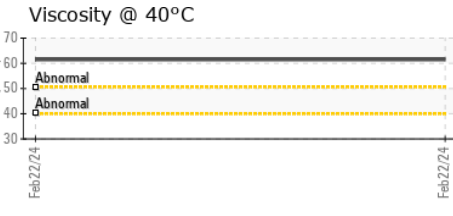
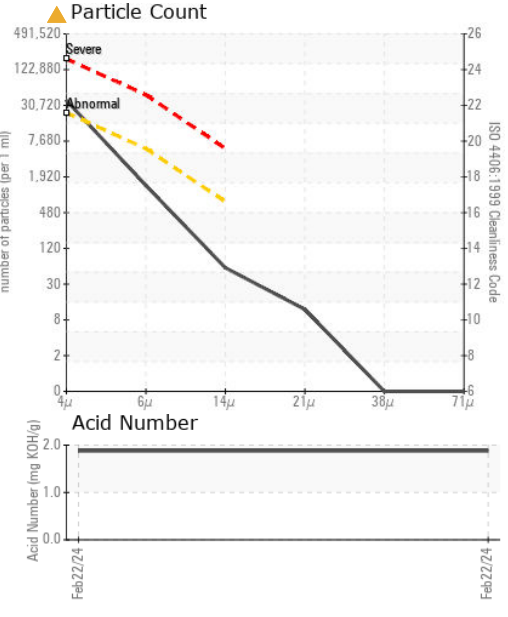
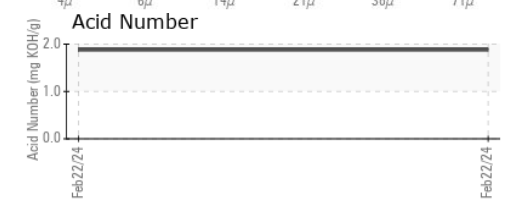
GRAPHS

FLUID DEGRADATION		method	limit/base	current	history1	history2
Acid Number (AN)	mg KOH/g	ASTM D974*		1.88	---	---

FLUID PROPERTIES		method	limit/base	current	history1	history2
Visc @ 40°C	cSt	ASTM D7279(m)		61.5	---	---
Visc @ 100°C	cSt	ASTM D7279(m)		9.5	---	---
Viscosity Index (VI)	Scale	ASTM D2270*		135	---	---
