OIL ANALYSIS REPORT

Laboratory : WearCheck - C8-1175 Appleby Line, Burlington, ON L7L 5H9
Sample No. : PC0087902
Lab Number : 02636422
Unique Number : 5785584
Test Package : IND 2 (Additional Tests: KV100, TAN Man, VI)

Green Infrastructure and Partners Inc (GIPI) - 286 - Shoring & Foundations
 151 Ram Forest Rd,
 Stouffville, ON
 CA L4A 2G8

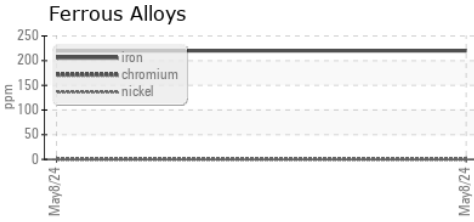
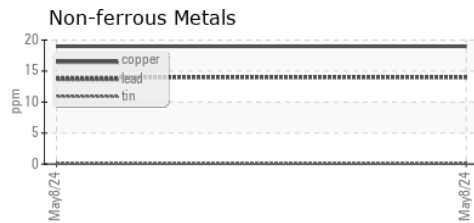
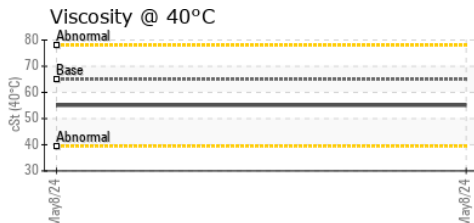
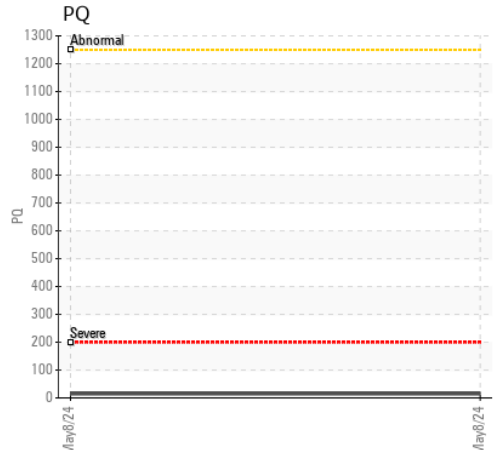
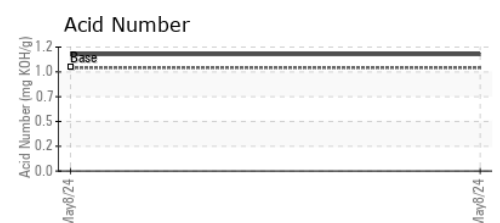
GRAPHS

FLUID PROPERTIES	method	limit/base	current	history1	history2	
Visc @ 40°C	cSt	ASTM D7279(m)	65	55.1	---	---
Visc @ 100°C	cSt	ASTM D7279(m)	11.8	9.5	---	---
Viscosity Index (VI)	Scale	ASTM D2270*	178	156	---	---
