OIL ANALYSIS REPORT

Laboratory : WearCheck - C8-1175 Appleby Line, Burlington, ON L7L 5H9 Green Infrastructure and Partners Inc (GPI) - 286 - Shoring & Foundations
Sample No. : PC0087859 **Received** : 10 Jun 2024 151 Ram Forest Rd,
Lab Number : 02640852 **Tested** : 12 Jun 2024 Stouffville, ON
Unique Number : 5798391 **Diagnosed** : 12 Jun 2024 - Wes Davis CA L4A 2G8
Test Package : IND 2 (Additional Tests: KV100, VI) Contact: Shannon Abbott
 sabbott@gipi.com

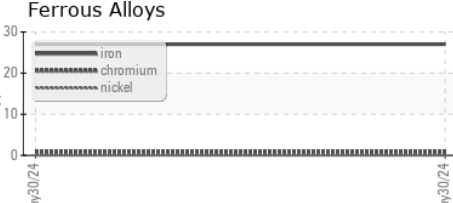
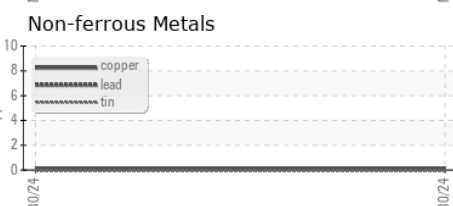
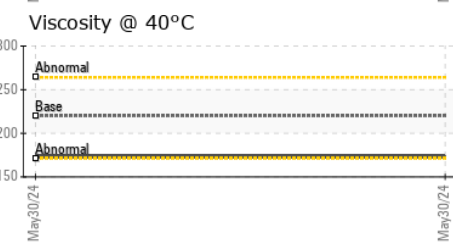
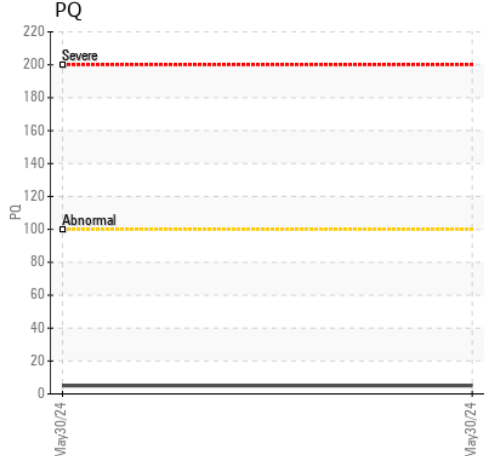
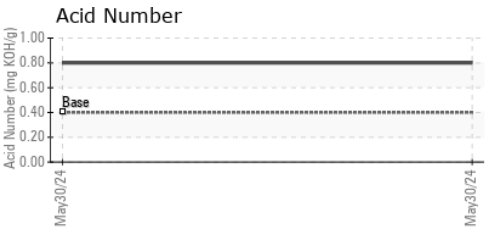
GRAPHS

FLUID PROPERTIES	method	limit/base	current	history1	history2	
Visc @ 40°C	cSt	ASTM D7279(m)	220	173	---	---
Visc @ 100°C	cSt	ASTM D7279(m)	19.35	17.5	---	---
Viscosity Index (VI)	Scale	ASTM D2270*	99	109	---	---
