OIL ANALYSIS REPORT

Machine Id
[] SHIP A - NORTH COIL CAR

Component
Hydraulic System

Fluid
PETRO CANADA HYDREX AW 46 (--- GAL)

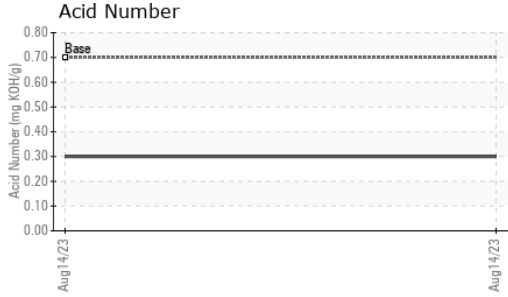
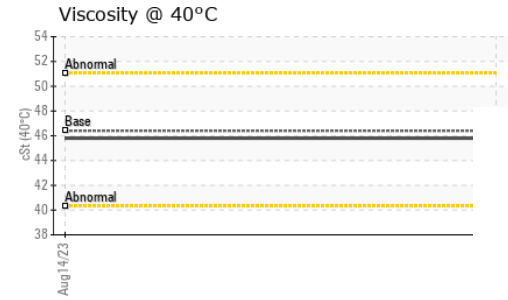
SAMPLE IMAGES

method	limit/base	current	history1	history2		
White Metal	scalar	*Visual	NONE	NONE	---	---
Yellow Metal	scalar	*Visual	NONE	NONE	---	---
Precipitate	scalar	*Visual	NONE	NONE	---	---
Silt	scalar	*Visual	NONE	NONE	---	---
Debris	scalar	*Visual	NONE	▲ MODER	---	---
Sand/Dirt	scalar	*Visual	NONE	NONE	---	---
Appearance	scalar	*Visual	NORML	NORML	---	---
Odor	scalar	*Visual	NORML	NORML	---	---
Emulsified Water	scalar	*Visual	>0.05	NEG	---	---
Free Water	scalar	*Visual		NEG	---	---

method	limit/base	current	history1	history2
Color

We recommend you service the filters on this component. Resample at the next service interval to monitor. We were unable to perform a particle count due to a high concentration of particles present in this sample.

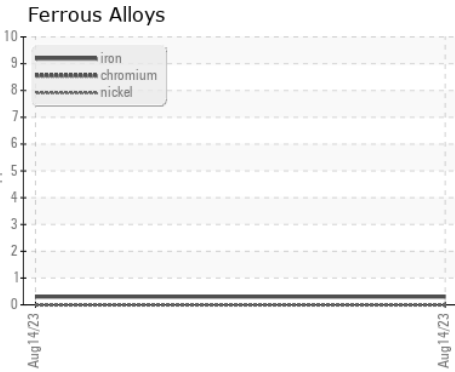
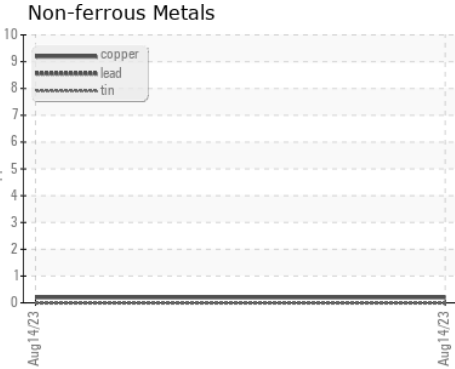
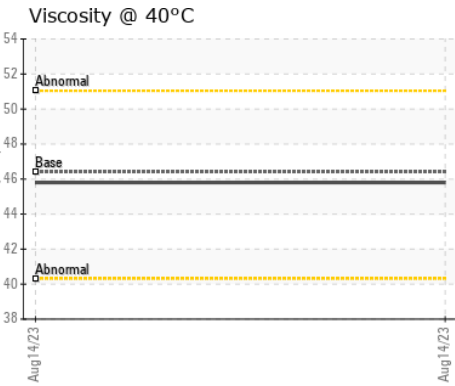
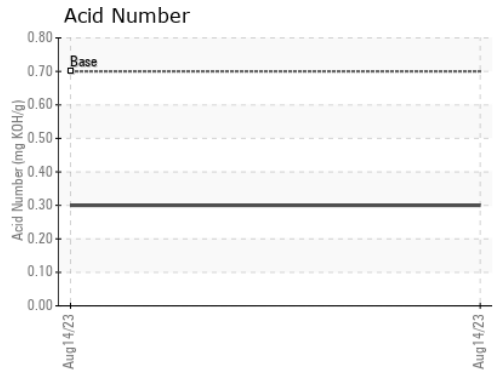
GRAPHS

method	limit/base	current	history1	history2
Visc @ 40°C	cSt ASTM D445	46.4	45.8	---
