# PROBLEM SUMMARY

Area  
**[98331669]**  
 Machine Id  
**KR-GR-001010 LIFT - DEMOLD MANIPLUX CRANE**  
 Component  
**Gearbox**  
 Fluid  
**GEAR OIL ISO 460 (--- GAL)**

# OIL ANALYSIS REPORT

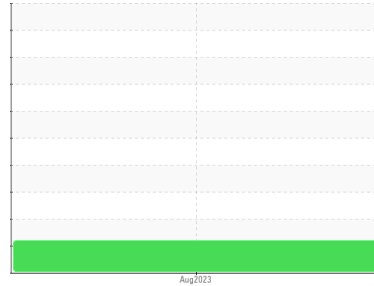
Sample Rating Trend

**SEDIMENT**

Sample Status				ABNORMAL	---	---
Silt	scalar	*Visual	NONE	▲ <b>HEAVY</b>	---	---
Debris	scalar	*Visual	NONE	▲ <b>MODER</b>	---	---

We recommend you service the filters on this component if applicable. Resample at the next service interval to monitor. We were unable to perform a particle count due to a high concentration of particles present in this sample.

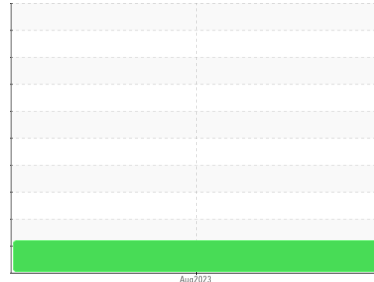
Sample Rating Trend

**SEDIMENT**

**Contamination**  
 Moderate concentration of visible dirt/debris present in the oil. There is a high amount of visible silt present in the sample.

**Recommendation**  
 We recommend you service the filters on this component if applicable. Resample at the next service interval to monitor. We were unable to perform a particle count due to a high concentration of particles present in this sample.
