# OIL ANALYSIS REPORT

Machine Id  
**920092-260371**

Component  
**Transmission (Auto)**  
Fluid  
**DEXRON III (--- GAL)**

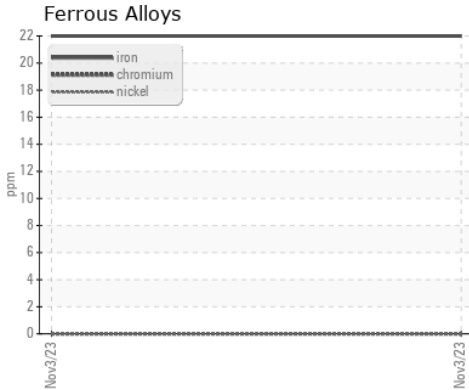
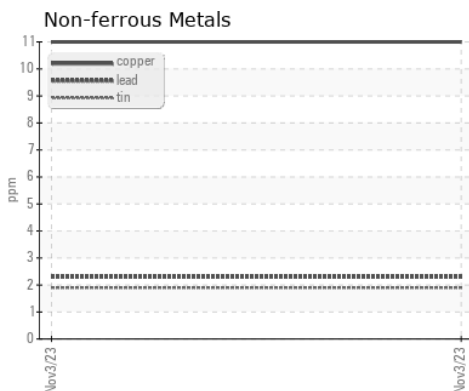
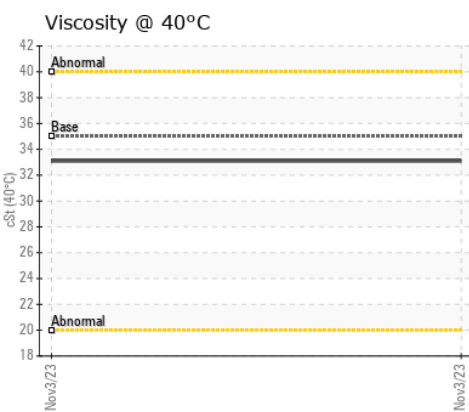
## GRAPHS

All component wear rates are normal.

There is no indication of any contamination in the fluid.

The condition of the fluid is acceptable for the time in service.

Resample at the next service interval to monitor.
