OIL ANALYSIS REPORT

Machine Id
INTERNATIONAL 398274
Component
Diesel Exhaust Fluid (DEF)
Fluid
DEF (Diesel Exhaust Fluid) (--- QTS)

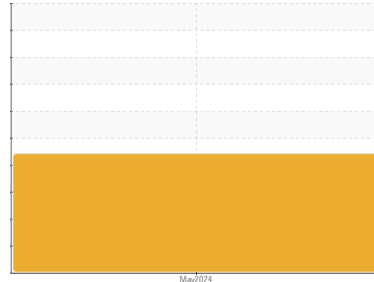
Sample Rating Trend

OFF SPEC

The diesel exhaust fluid (def) specification testing is lower than normal. Urea content is low.

Fluid does not meet ISO 22241-2 requirements.
Contact supplier.

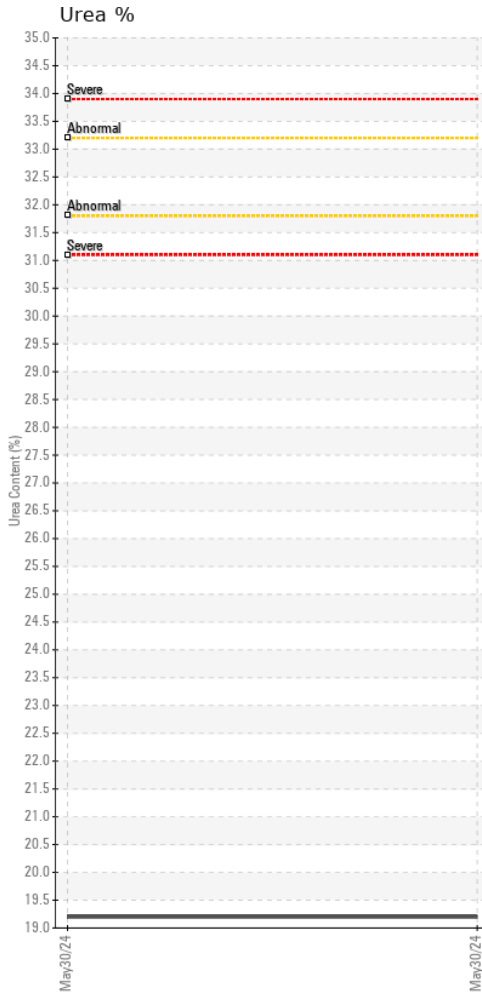
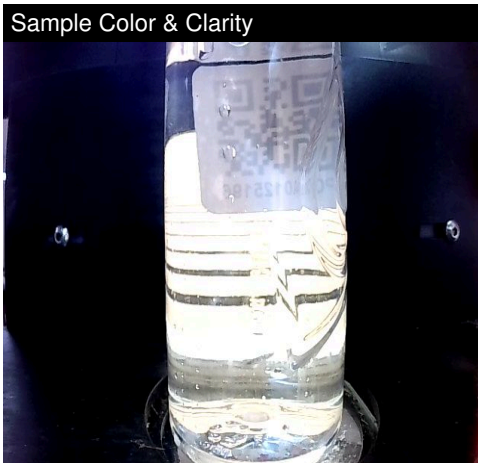
GRAPHS

FLUID PROPERTIES		method	limit/base	current	history1	history2
Urea Content	%	ISO 22241	<31.8	▲ 19.2	---	---
Density @ 20°C	g/cm3	ISO 22241	>1.0930	▲ 1.0512	---	---
Refracting Index		ISO 22241	<1.3814	▲ 1.3618	---	---
Appearance	scalar	*Visual		Clear & Bright	---	---
