CONSTRUCTION EQUIPMENT

354877 VOLVO L120H 632062 - TRANSMISSION (AUTO)

Sample No: VCP379511
Oil Type: VOLVO AUTOMATIC TRANSMISSION FLUID AT102
Job No: 354877

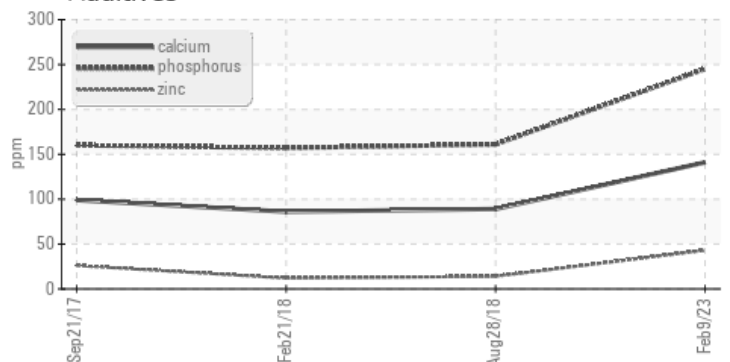
Additives

Calcium	ppm	141	89	86	99
Magnesium	ppm	26	2	1	1
Zinc	ppm	43	14	12	26
Phosphorus	ppm	245	161	157	160
Barium	ppm	0	<1	<1	3
Boron	ppm	89	60	66	49
