CONSTRUCTION EQUIPMENT

370672 VOLVO L70C 15096 - DIESEL ENGINE

Sample No: VCP391701
Oil Type: VOLVO ULTRA DIESEL ENGINE OIL 15W40 VDS-3
Job No: 370672

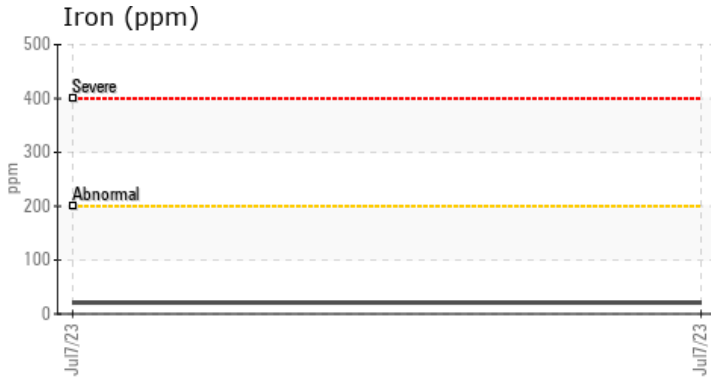
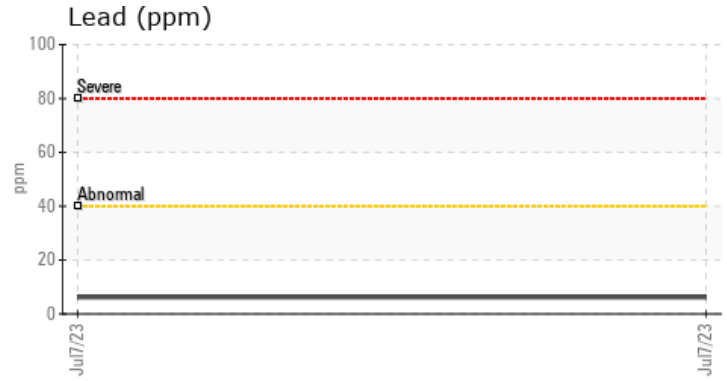
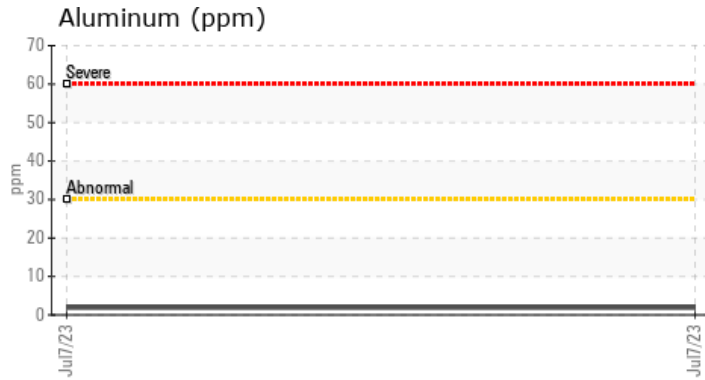
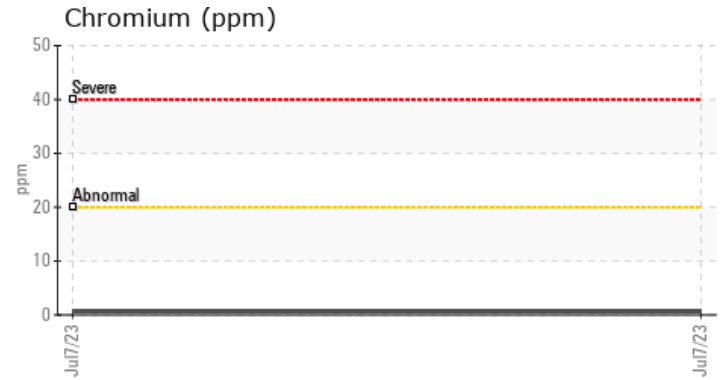
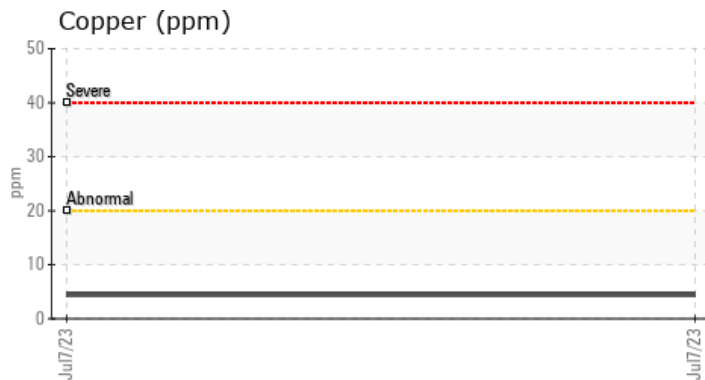
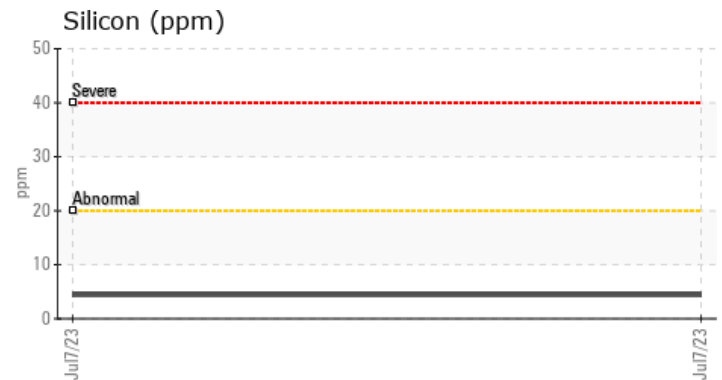
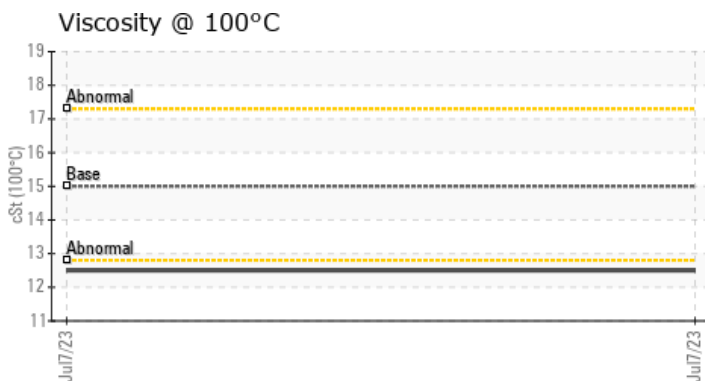
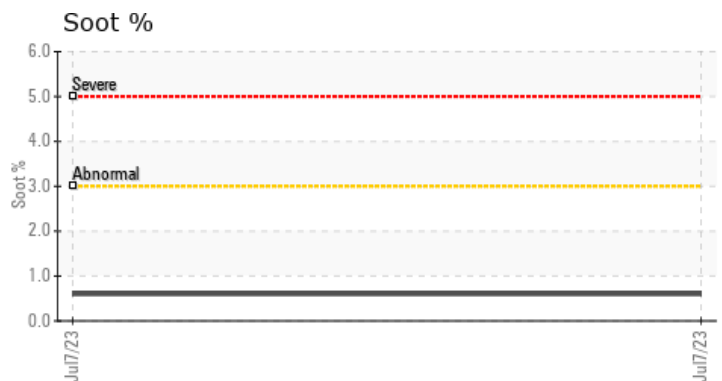
GRAPHS

Aucune mesure corrective n'est recommandée pour l'instant. Confirm the source of the lubricant being utilized for top-up/fill. Échantillonner de nouveau l'équipement au prochain intervalle de vidange afin d'en surveiller la condition. Les taux d'usure de tous les composants sont normaux. Légère dilution de carburant dans l'huile. Aucun autre contaminant n'a été détecté dans l'huile. Les niveaux d'additifs indiquent l'ajout d'une autre marque ou d'un autre type d'huile. L'état de l'huile est acceptable pour la durée de service.
