# CONSTRUCTION EQUIPMENT

## IMPACT AUTO 382450 VOLVO L90H 623901 - DIESEL ENGINE

**Sample No:** VCP379974  
**Oil Type:** VOLVO ULTRA DIESEL ENGINE OIL 15W40 VDS-3  
**Job No:** 382450

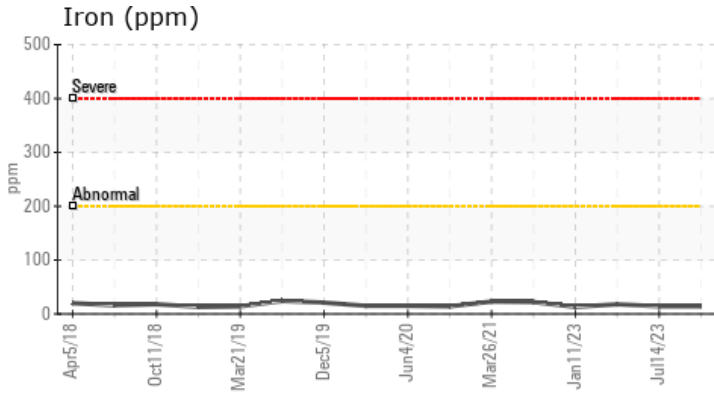
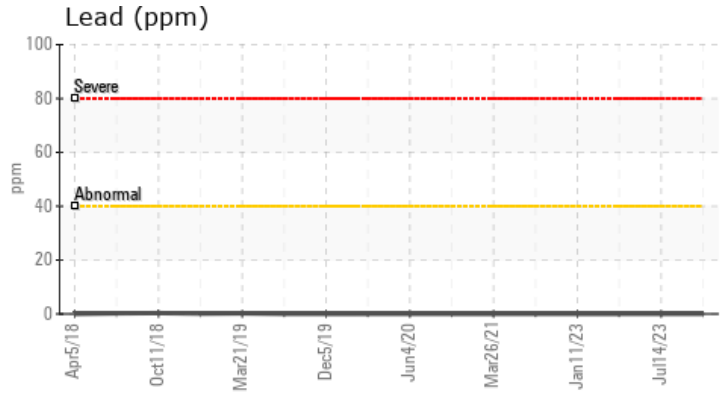
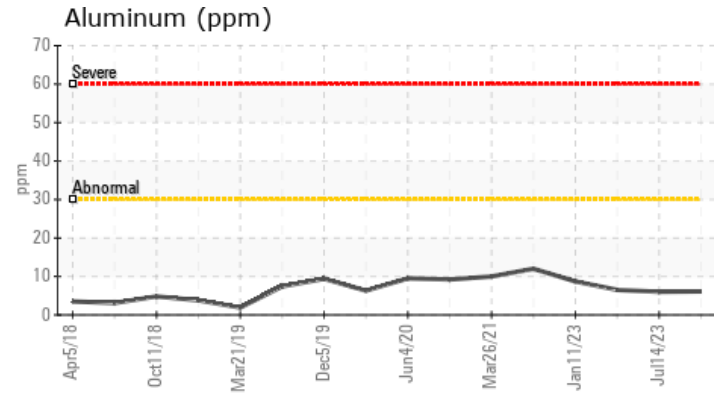
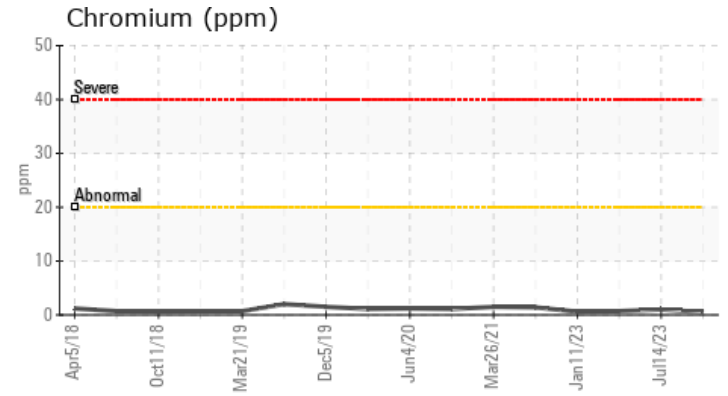
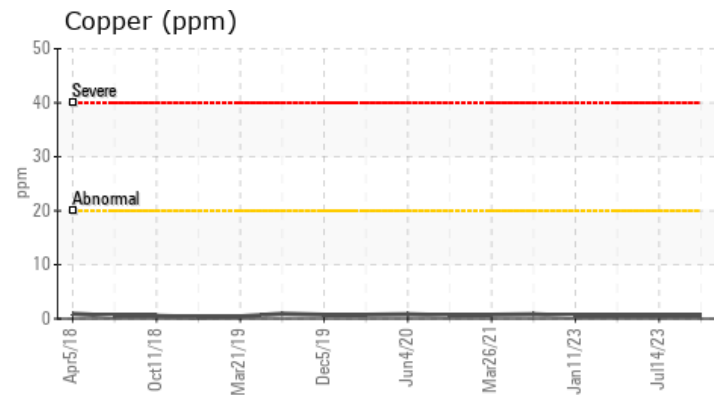
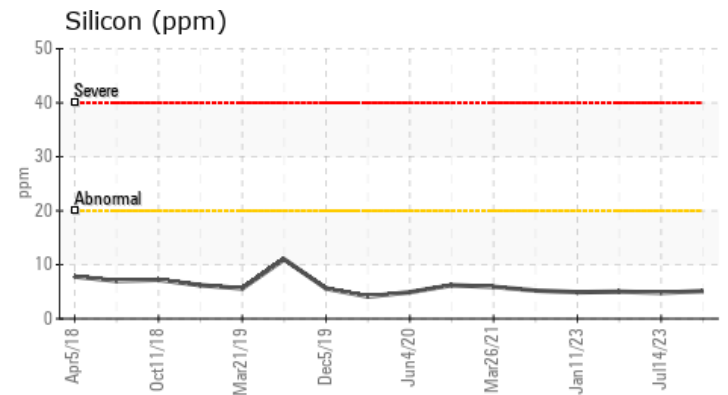
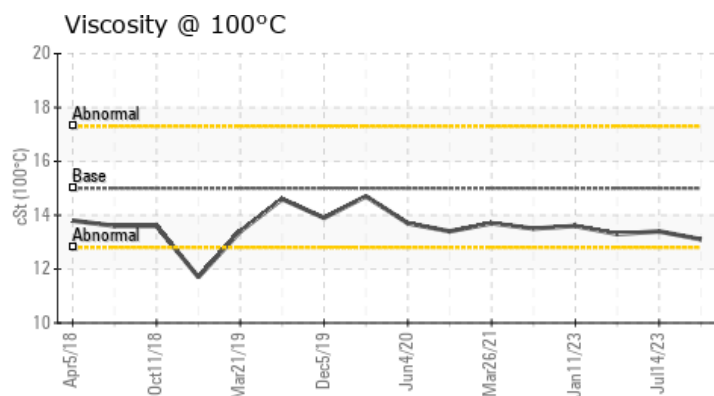
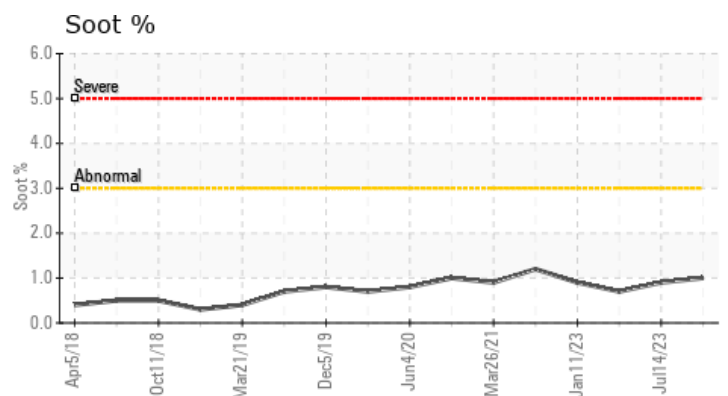
## VOLVO GRAPHS

Resample at the next service interval to monitor. All component wear rates are normal. There is no indication of any contamination in the oil. The condition of the oil is acceptable for the time in service.
