# CONSTRUCTION EQUIPMENT

## IMPACT AUTO 384876 VOLVO L90G 617649 - DIESEL ENGINE

**Sample No:** VCP394058  
**Oil Type:** VOLVO ULTRA DIESEL ENGINE OIL 15W40 VDS-3  
**Job No:** 384876

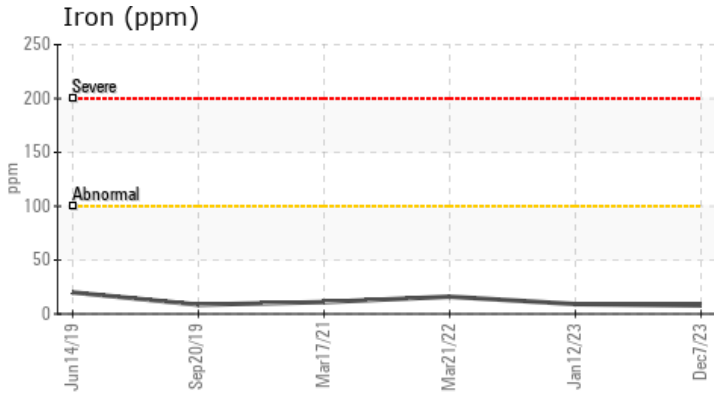
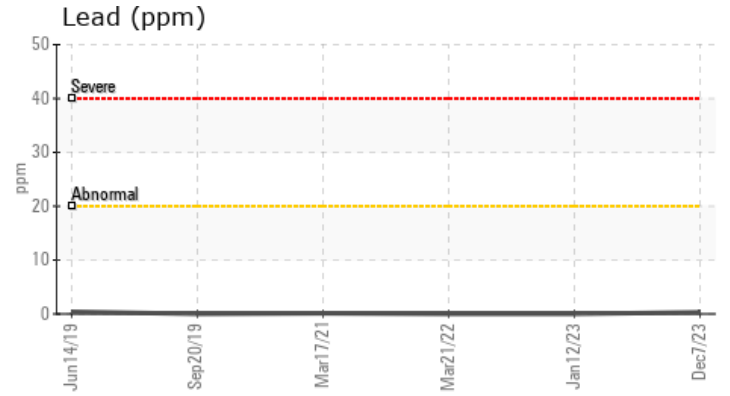
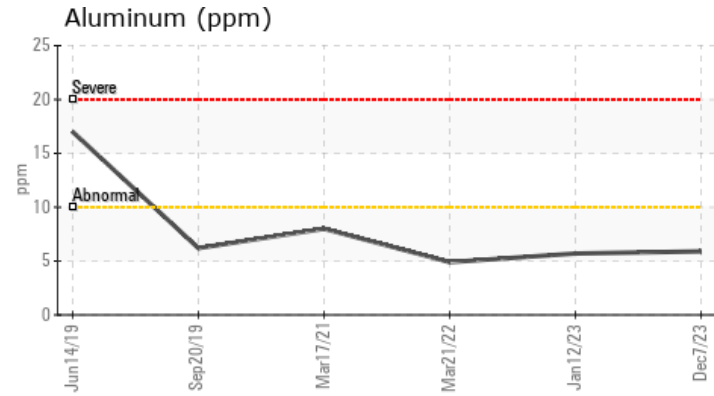
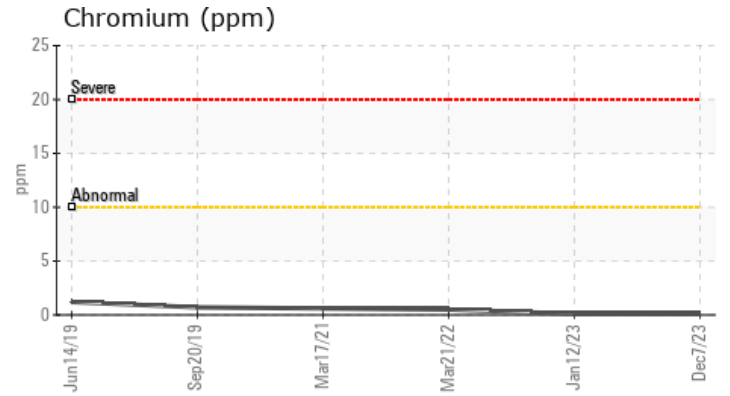
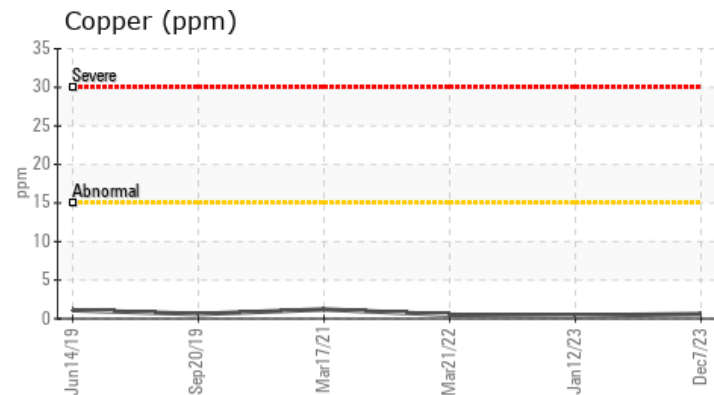
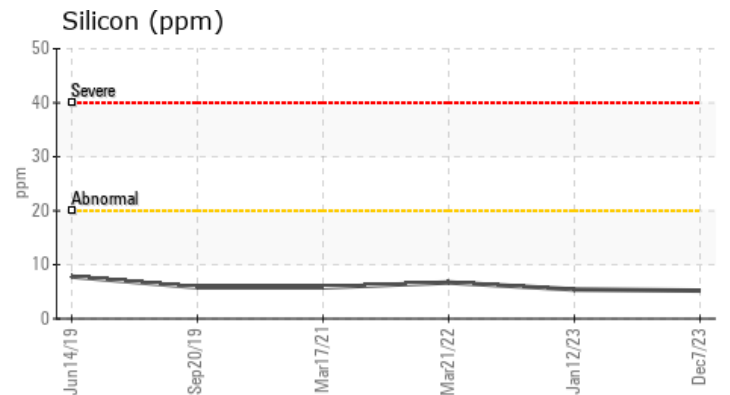
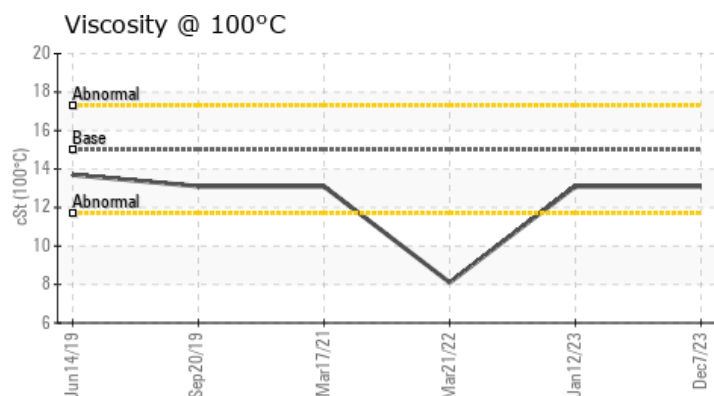
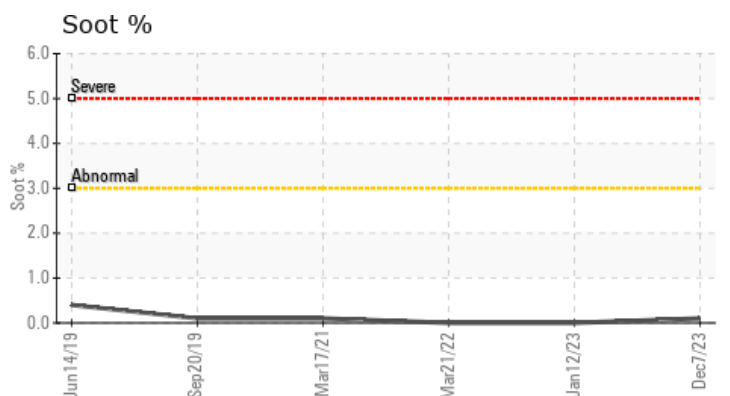
## VOLVO GRAPHS

Resample at the next service interval to monitor. All component wear rates are normal. There is no indication of any contamination in the oil. The condition of the oil is acceptable for the time in service.
