# CONSTRUCTION EQUIPMENT

REGION OF PEEL 8-404173 VOLVO L60H 622565 - DIESEL ENGINE

**Sample No:** VCP450371  
**Oil Type:** DIESEL ENGINE OIL SAE 40  
**Job No:** 8-404173

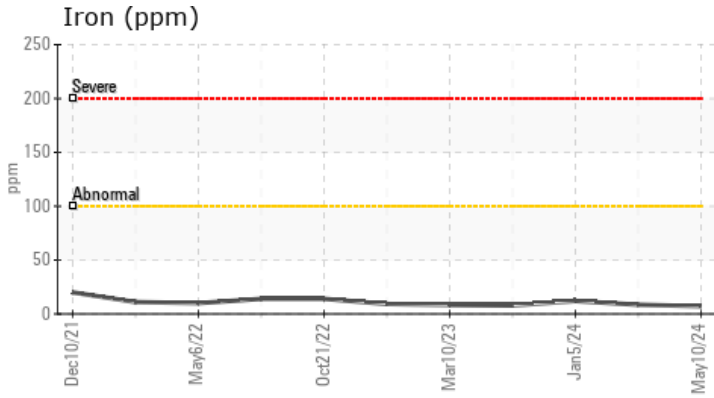
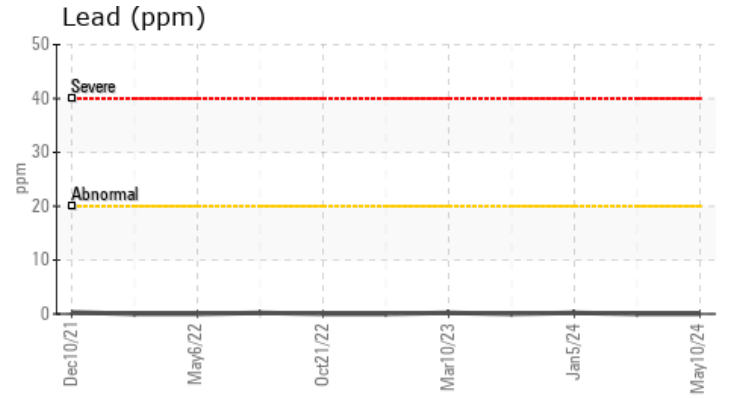
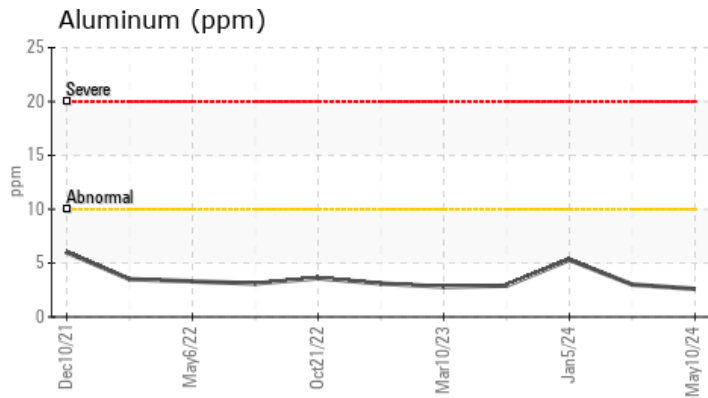
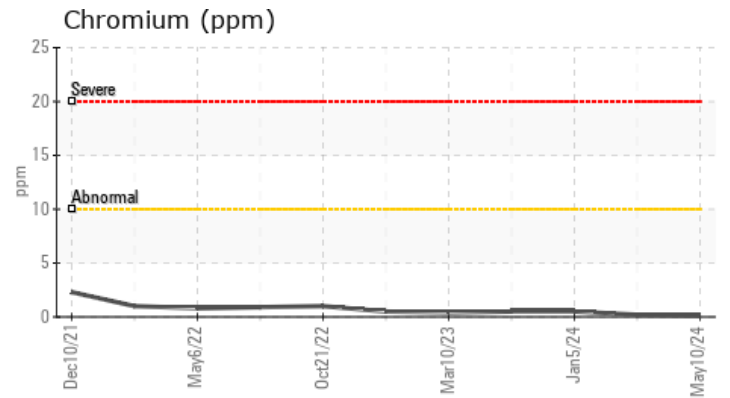
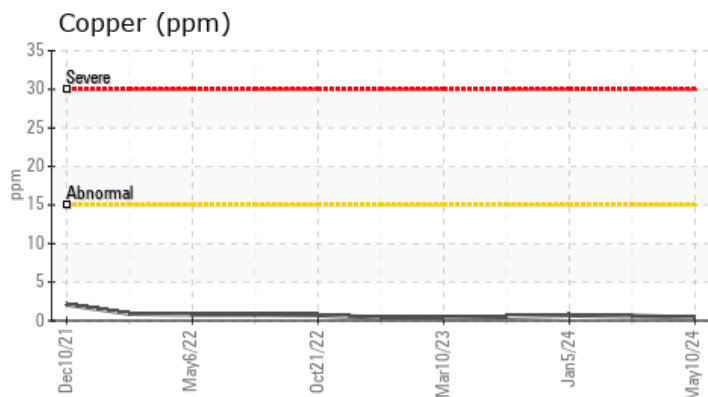
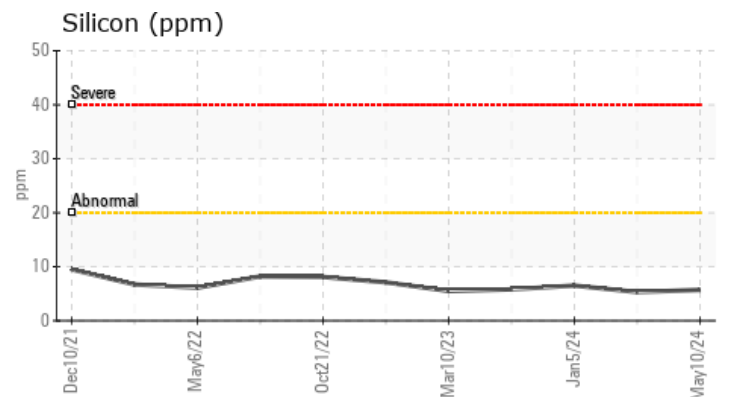
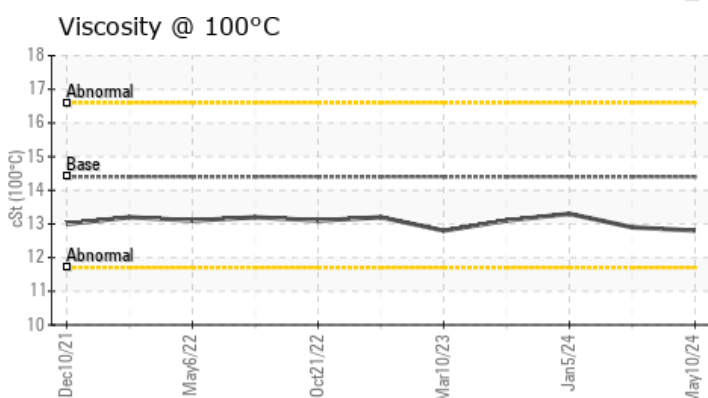
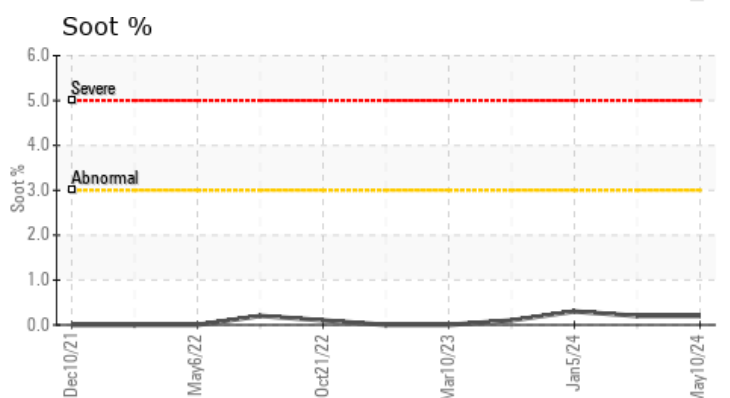
## GRAPHS

Resample at the next service interval to monitor. All component wear rates are normal. There is no indication of any contamination in the oil. The condition of the oil is acceptable for the time in service.
