SPM567753 HERC VOLVO L70H 624578 - HYDRAULIC SYSTEM

Sample No: VCP406241
Oil Type: VOLVO SUPER HYDRAULIC OIL 46
Job No: SPM567753 HERC

SAMPLE INFORMATION

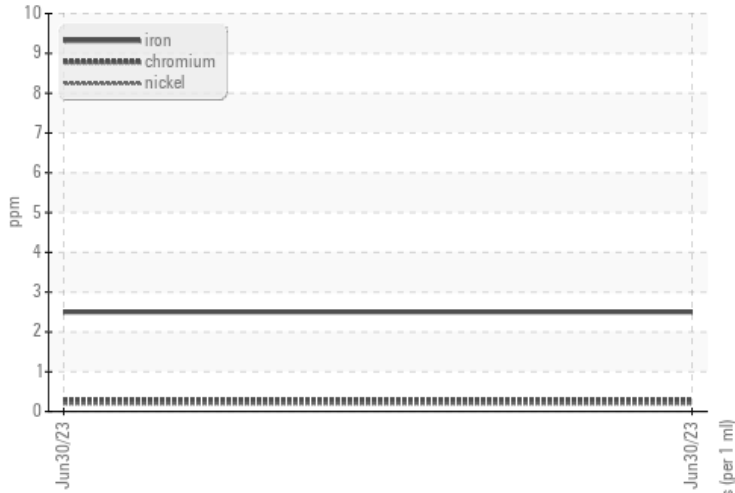
Ferrous Alloys

Iron	ppm	█ 2	---	---	---
Copper	ppm	█ 2	---	---	---
Lead	ppm	█ 1	---	---	---
Tin	ppm	█ 0	---	---	---
Aluminum	ppm	█ 0	---	---	---
Chromium	ppm	█ <1	---	---	---
Molybdenum	ppm	█ <1	---	---	---
Nickel	ppm	█ <1	---	---	---
Titanium	ppm	0	---	---	---
Silver	ppm	0	---	---	---
Manganese	ppm	█ 0	---	---	---
Vanadium	ppm	0	---	---	---

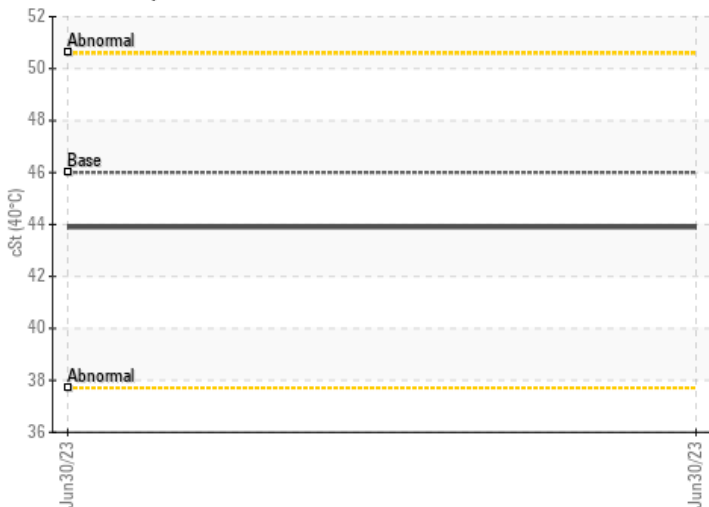
Viscosity @ 40°C

Visc @ 40°C	cSt	█ 43.9	---	---	---
Acid Number (AN)	mg KOH/g	█ 0.40	---	---	---
