CONSTRUCTION EQUIPMENT

VOLVO L110H 631121 - TRANSMISSION (AUTO)

Sample No: VCP412086

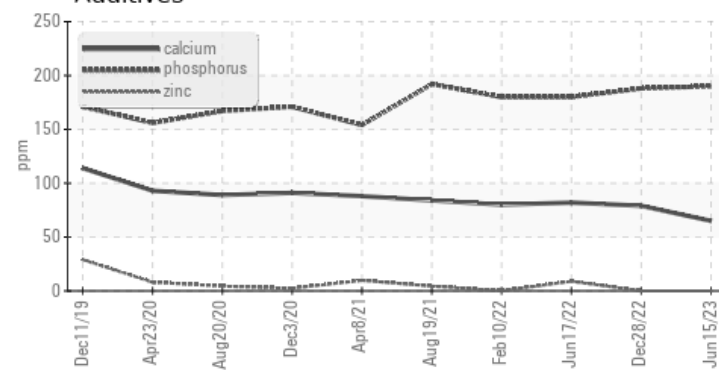
Additives

Calcium	ppm	65	79	82	80
Magnesium	ppm	0	1	2	2
Zinc	ppm	0	0	9	0
Phosphorus	ppm	190	188	180	180
Barium	ppm	0	0	2	0
Boron	ppm	97	79	96	94
