317506 VOLVO A30G 742109 - TRANSMISSION (AUTO)

Sample No: VCP411550
Oil Type: VOLVO AUTOMATIC TRANSMISSION FLUID AT102
Job No: 317506

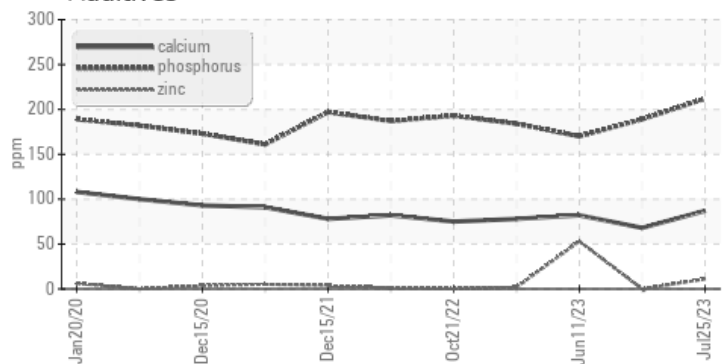
Additives

Calcium	ppm	87	68	82	78
Magnesium	ppm	4	0	0	2
Zinc	ppm	11	0	53	2
Phosphorus	ppm	212	189	170	184
Barium	ppm	0	0	0	0
Boron	ppm	91	90	38	93
