CONSTRUCTION EQUIPMENT

10720 VOLVO L150G 23510 - TRANSMISSION (AUTO)

Sample No: VCP416467

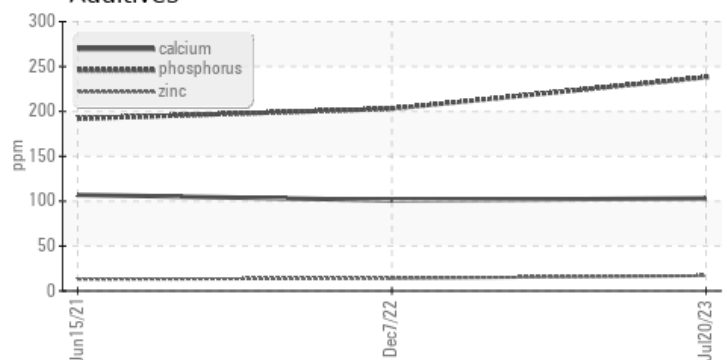
Additives

Calcium	ppm	103	101	107	---
Magnesium	ppm	0	7	<1	---
Zinc	ppm	17	14	13	---
Phosphorus	ppm	238	203	192	---
Barium	ppm	0	0	0	---
Boron	ppm	111	84	79	---
