CONSTRUCTION EQUIPMENT

VOLVO A40G 342176 - BRAKE COOLING SYSTEM

Sample No: VCP417013
Oil Type: VOLVO WB 102
Job No:

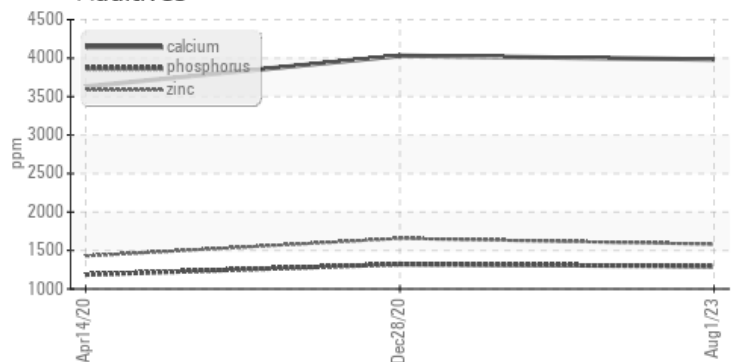
Additives

Calcium	ppm	3982	4031	3632	---
Magnesium	ppm	17	16	6	---
Zinc	ppm	1581	1657	1428	---
Phosphorus	ppm	1294	1321	1185	---
Barium	ppm	2	0	0	---
Boron	ppm	135	116	91	---
