CONSTRUCTION EQUIPMENT

VOLVO L150G NR23026 - TRANSMISSION (AUTO)

Sample No: VCP418077
Oil Type: MOBIL MOBILTRANS AST 30
Job No:

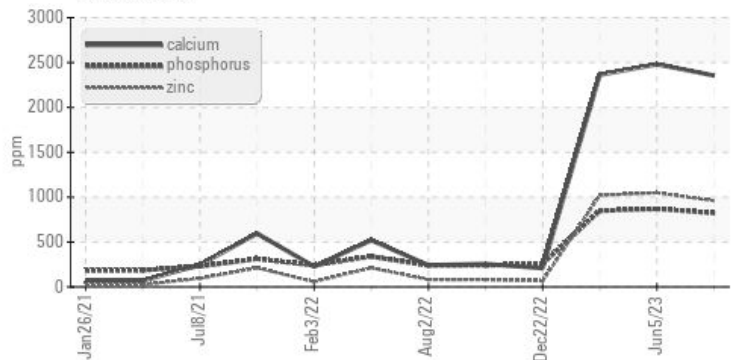
Additives

Calcium	ppm	2355	2481	2363	209
Magnesium	ppm	26	25	29	6
Zinc	ppm	959	1048	1020	67
Phosphorus	ppm	823	869	847	258
Barium	ppm	0	<1	0	0
Boron	ppm	56	53	52	82
