D12756 VOLVO L110G 8939 - TRANSMISSION (AUTO)

Sample No: VCP360499
Oil Type: VOLVO AUTOMATIC TRANSMISSION FLUID AT102
Job No: D12756

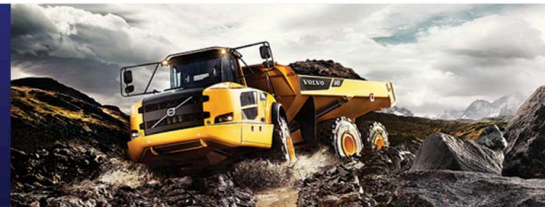
Iron (ppm)

Iron	ppm	█ 32	---	---	---
Copper	ppm	█ 5	---	---	---
Lead	ppm	█ <1	---	---	---
Tin	ppm	█ <1	---	---	---
Aluminum	ppm	█ 2	---	---	---
Chromium	ppm	█ <1	---	---	---
Molybdenum	ppm	█ <1	---	---	---
Nickel	ppm	█ 0	---	---	---
Titanium	ppm	0	---	---	---
Silver	ppm	█ 0	---	---	---
Manganese	ppm	█ 1	---	---	---
Vanadium	ppm	0	---	---	---

Resample at the next service interval to monitor. All component wear rates are normal. The wear metal levels do not reflect the reported issue. There is no indication of any contamination in the fluid. The condition of the fluid is acceptable for the time in service.

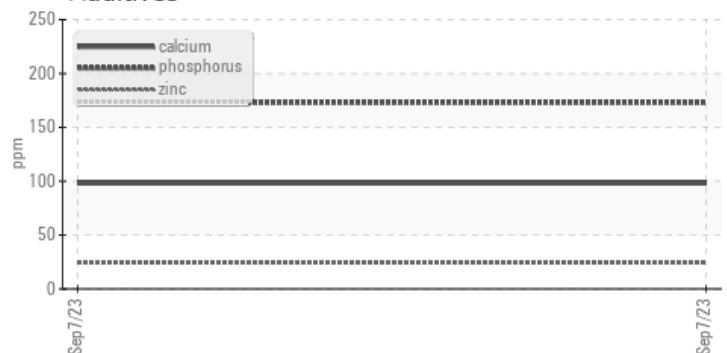
Additives

Calcium	ppm	█ 98	---	---	---
Magnesium	ppm	█ 2	---	---	---
Zinc	ppm	█ 24	---	---	---
Phosphorus	ppm	█ 173	---	---	---
Barium	ppm	█ 0	---	---	---
Boron	ppm	█ 54	---	---	---
