# CONSTRUCTION EQUIPMENT

## SWA329757-20 VOLVO L220H 2823 - TRANSMISSION (AUTO)

**Sample No:** VCP407429  
**Oil Type:** VOLVO AT 102  
**Job No:** SWA329757-20

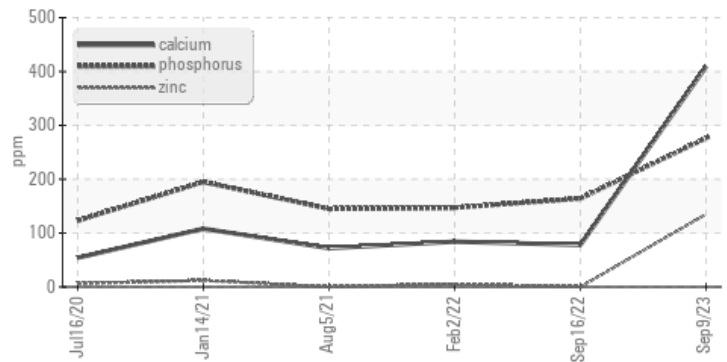
### Additives

Calcium	ppm	<b>409</b>	78	84	72
Magnesium	ppm	<b>11</b>	<1	<1	1
Zinc	ppm	<b>135</b>	0	5	0
Phosphorus	ppm	<b>276</b>	164	147	145
Barium	ppm	<b>0</b>	0	0	0
Boron	ppm	<b>64</b>	64	74	87
