600105 CRC VOLVO L120H 632093 - TRANSMISSION (AUTO)

Sample No: VCP346238
Oil Type: VOLVO AUTOMATIC TRANSMISSION FLUID AT102
Job No: 600105 CRC

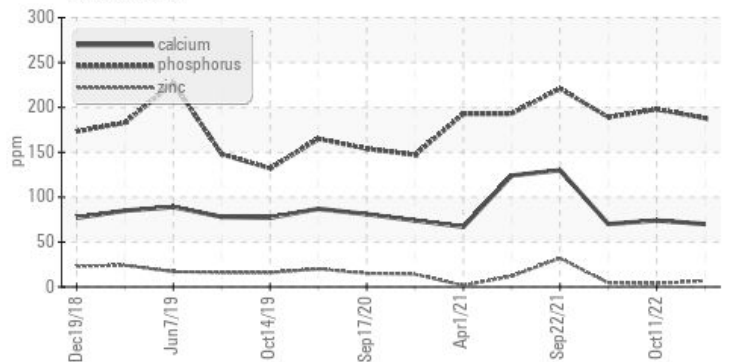
Additives

Calcium	ppm	70	74	70	130
Magnesium	ppm	2	1	0	13
Zinc	ppm	7	4	4	32
Phosphorus	ppm	188	198	189	221
Barium	ppm	2	0	0	0
Boron	ppm	84	84	78	89
