CONSTRUCTION EQUIPMENT

607997 MOSAIC VOLVO A45G 342286 - DIESEL ENGINE

Sample No: VCP414729
Oil Type: VOLVO ULTRA DIESEL ENGINE OIL 15W40 VDS-3
Job No: 607997 MOSAIC

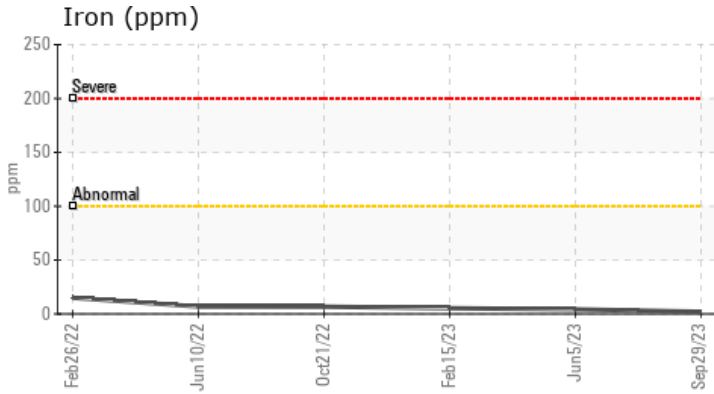
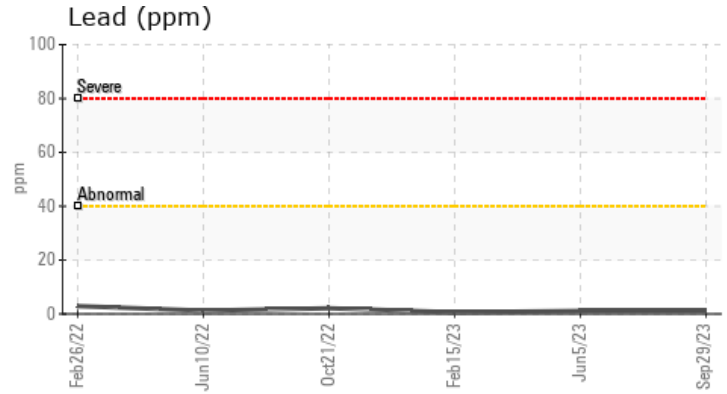
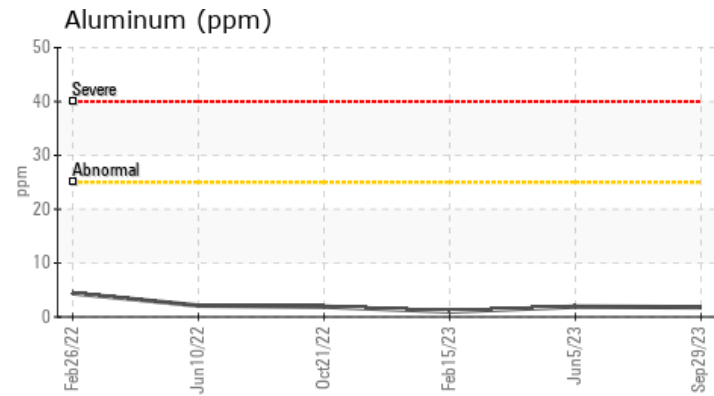
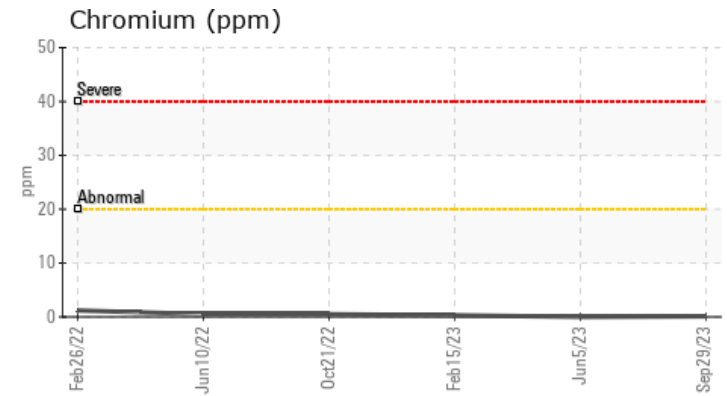
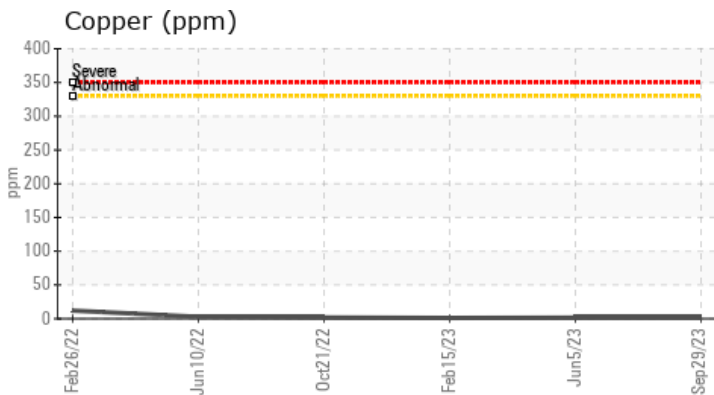
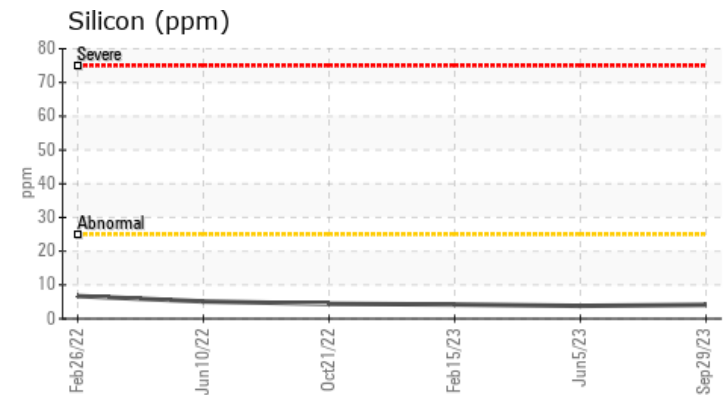
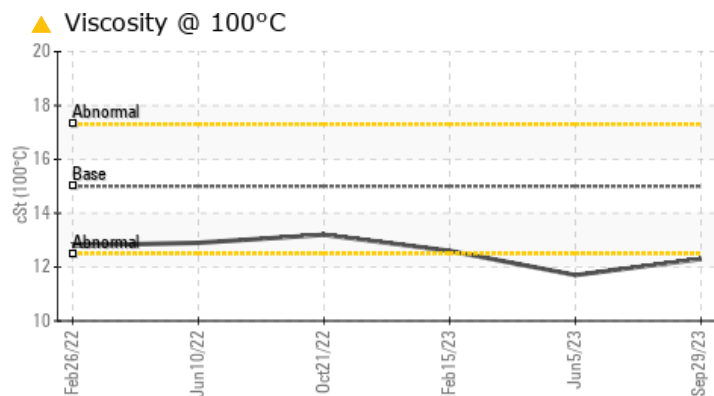
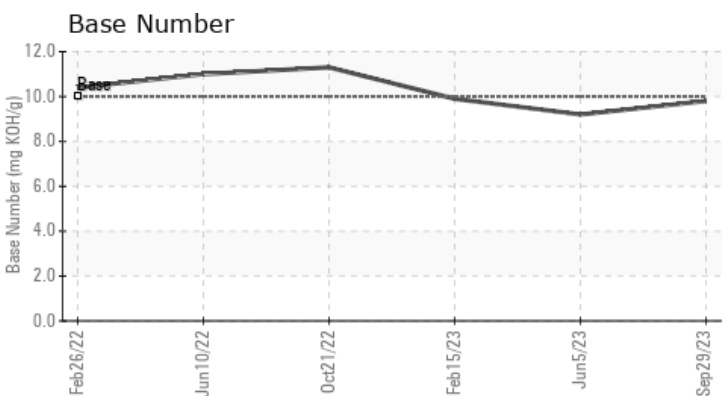
GRAPHS

Oil and filter change at the time of sampling has been noted. Resample at the next service interval to monitor. All component wear rates are normal. There is no indication of any contamination in the oil. The oil viscosity is lower than normal. The BN result indicates that there is suitable alkalinity remaining in the oil. Confirm oil type.
