# CONSTRUCTION EQUIPMENT

## VOLVO L220H 3347 - DIESEL ENGINE

**Sample No:** VCP432427  
**Oil Type:** SHELL ROTELLA T3 15W40  
**Job No:**

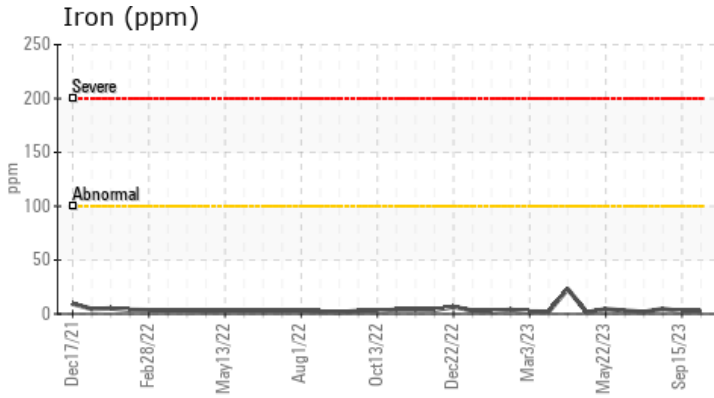
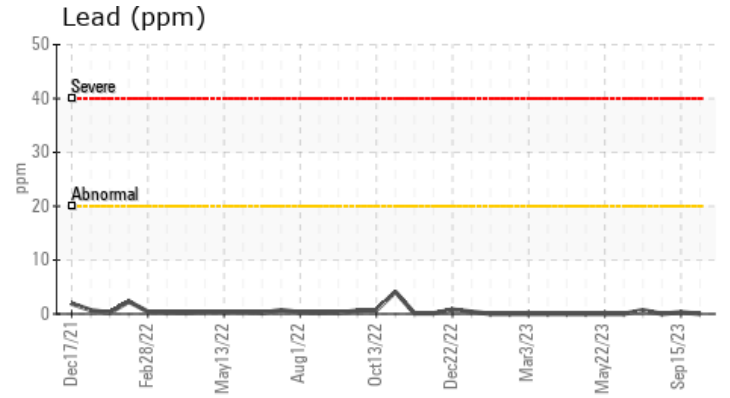
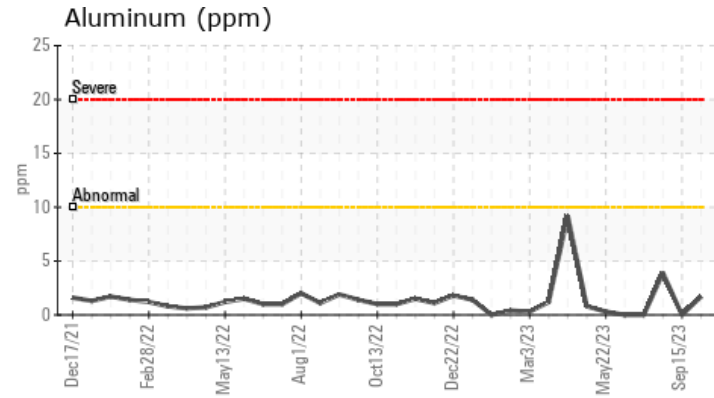
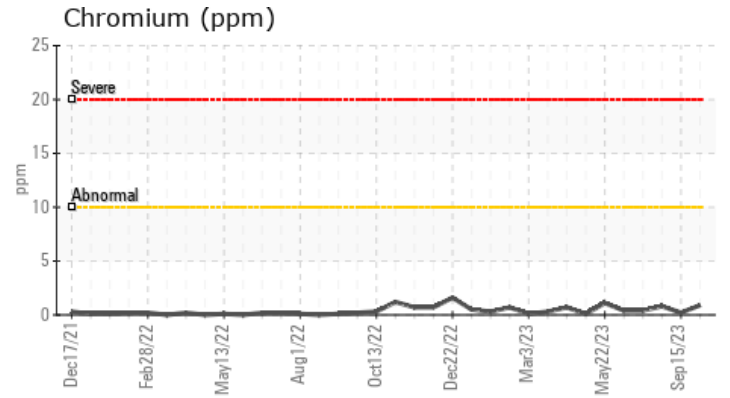
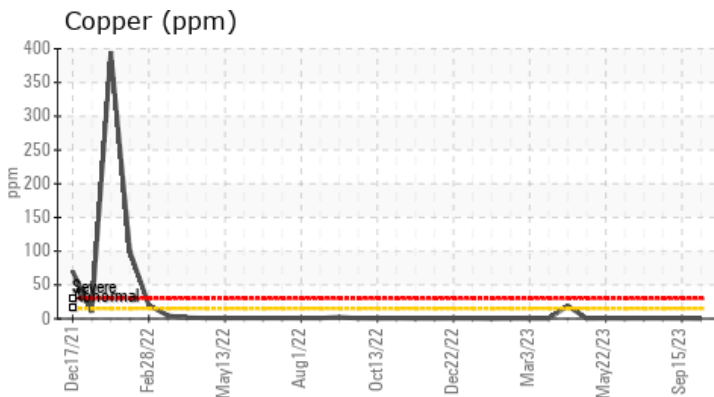
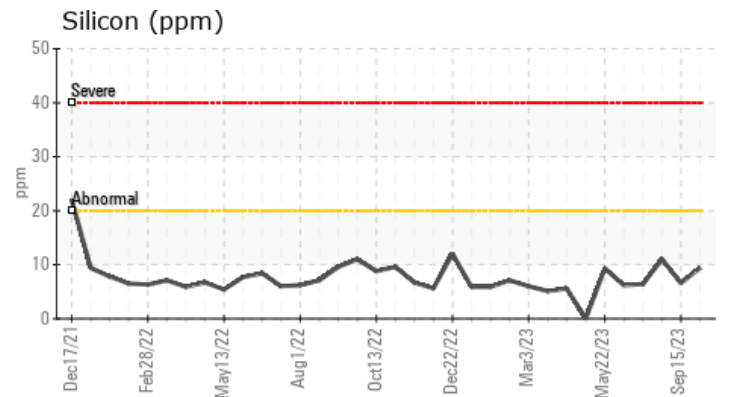
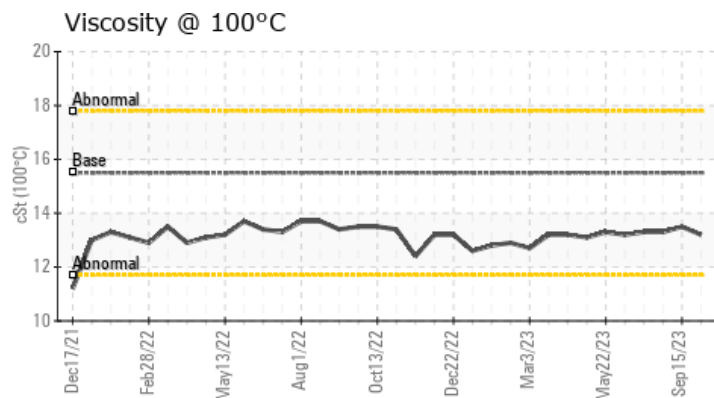
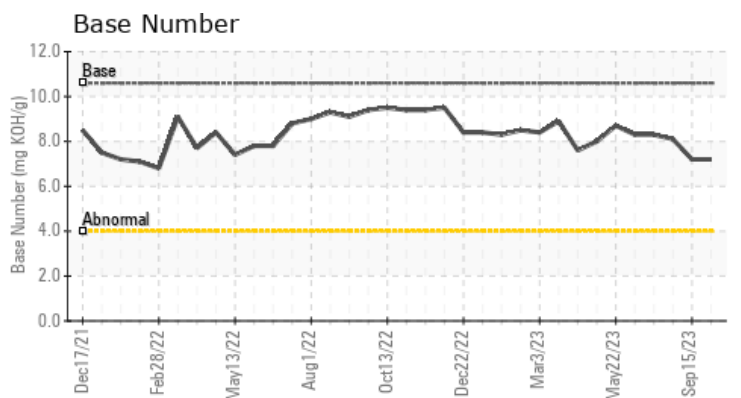
## VOLVO GRAPHS

Resample at the next service interval to monitor. All component wear rates are normal. There is no indication of any contamination in the oil. The BN result indicates that there is suitable alkalinity remaining in the oil. Confirm oil type. The condition of the oil is suitable for further service.
