SPM619466 MBP VOLVO MC60B 70091 - HYDRAULIC SYSTEM

Sample No: VCP425155
Oil Type: VOLVO SUPER HYDRAULIC OIL 46
Job No: SPM619466 MBP

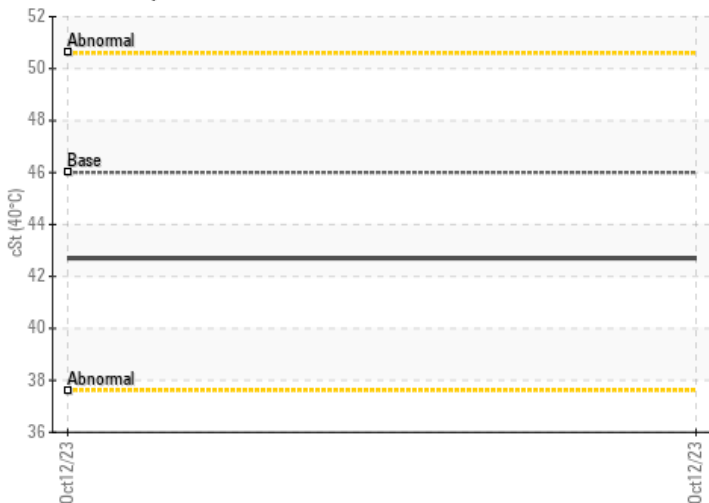
Viscosity @ 40°C

Visc @ 40°C	cSt	█ 42.7	---	---	---
Acid Number (AN)	mg KOH/g	█ 0.20	---	---	---
