CONSTRUCTION EQUIPMENT

VOLVO L150H 7044 - TRANSMISSION (AUTO)

Sample No: VCP376067
Oil Type: VOLVO AUTOMATIC TRANSMISSION FLUID AT102
Job No:

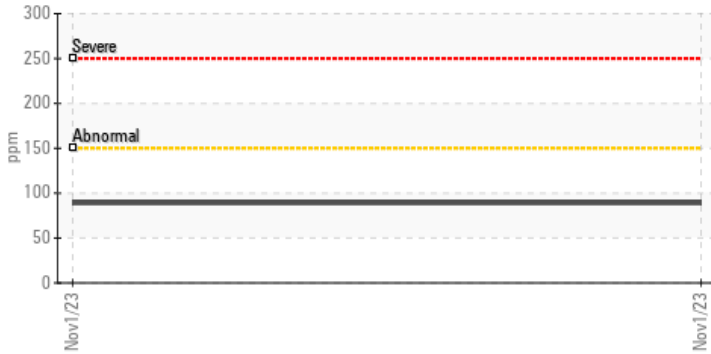
Iron (ppm)

Iron	ppm	█ 89	---	---	---
Copper	ppm	█ 8	---	---	---
Lead	ppm	█ 0	---	---	---
Tin	ppm	█ 0	---	---	---
Aluminum	ppm	█ <1	---	---	---
Chromium	ppm	█ <1	---	---	---
Molybdenum	ppm	█ 0	---	---	---
Nickel	ppm	█ 0	---	---	---
Titanium	ppm	█ 0	---	---	---
Silver	ppm	█ 0	---	---	---
Manganese	ppm	█ 4	---	---	---
Vanadium	ppm	█ 0	---	---	---

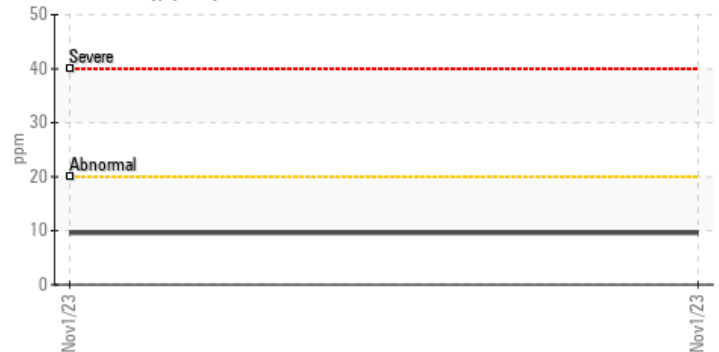
Silicon (ppm)

Silicon	ppm	█ 10	---	---	---
Sodium	ppm	█ 5	---	---	---
Potassium	ppm	█ <1	---	---	---

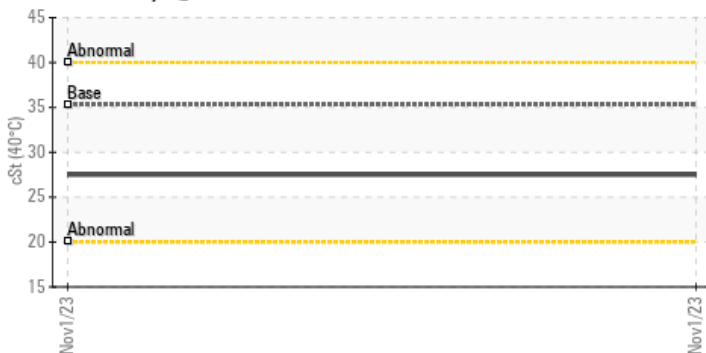
Viscosity @ 40°C

Visc @ 40°C	cSt	█ 27.5	---	---	---
-------------	-----	--------	-----	-----	-----

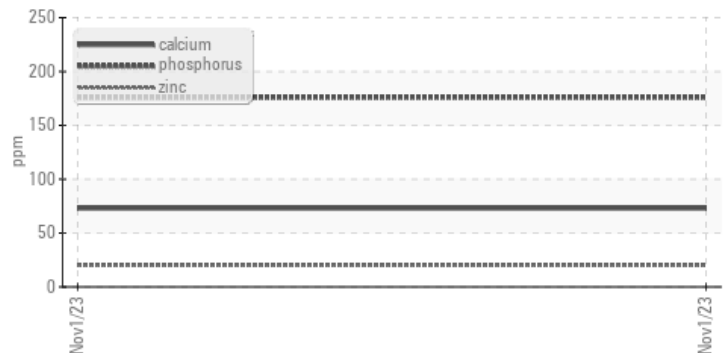
Additives

Calcium	ppm	█ 73	---	---	---
Magnesium	ppm	█ 0	---	---	---
Zinc	ppm	█ 20	---	---	---
Phosphorus	ppm	█ 176	---	---	---
Barium	ppm	█ 2	---	---	---
Boron	ppm	█ 68	---	---	---
