CONSTRUCTION EQUIPMENT

W14799 VOLVO L220H 2915 - TRANSMISSION (AUTO)

Sample No: VCP435136
Oil Type: VOLVO AUTOMATIC TRANSMISSION FLUID AT102
Job No: W14799

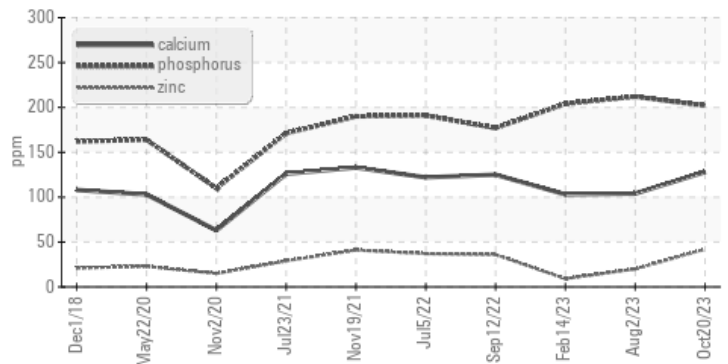
Additives

Calcium	ppm	128	104	103	125
Magnesium	ppm	10	16	11	14
Zinc	ppm	42	20	9	36
Phosphorus	ppm	202	212	204	177
Barium	ppm	0	0	0	0
Boron	ppm	83	89	100	64
