# CONSTRUCTION EQUIPMENT

## VOLVO L150H 7248 - COOLANT

**Sample No:** VCP416546  
**Oil Type:** HYBRID (HOAT) COOLANT  
**Job No:**

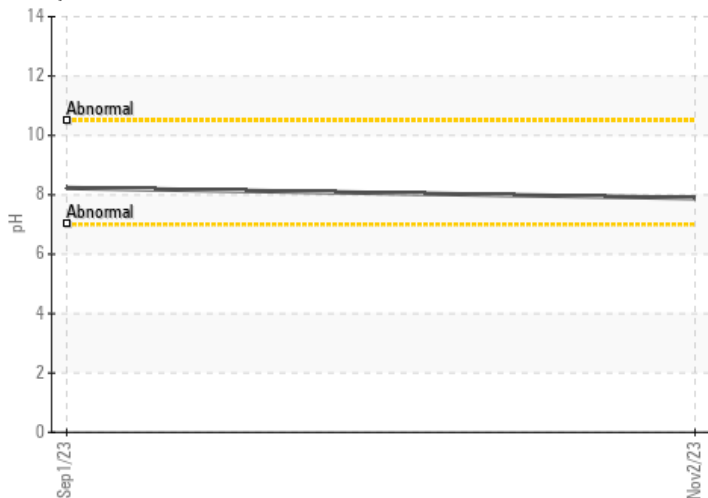
### pH

pH	Scale 0-14	<b>7.89</b>	8.23	---	---
Reserve Alkalinity	Scale 0-20	---	---	---	---
Nitrites	ppm	<b>NT</b>	NT	---	---
Percentage Glycol	%	<b>44.1</b>	44.1	---	---
Freezing Point	°C	<b>-21</b>	-21	---	---

No corrective action is recommended at this time. The fluid is suitable for further service. There is no indication of any contamination in the coolant. Carboxylate test failed. The glycol level is acceptable. The pH level of this fluid is within the acceptable limits.
