CONSTRUCTION EQUIPMENT

W02007731 VOLVO A40E 13778 - DIESEL ENGINE

Sample No: VCP418741
Oil Type: MOBIL 15W40
Job No: W02007731

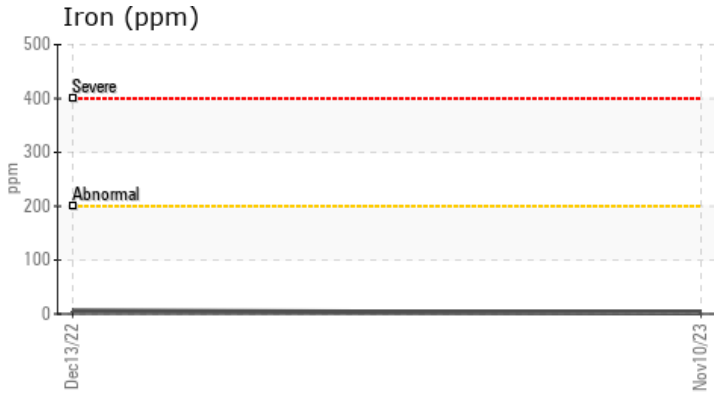
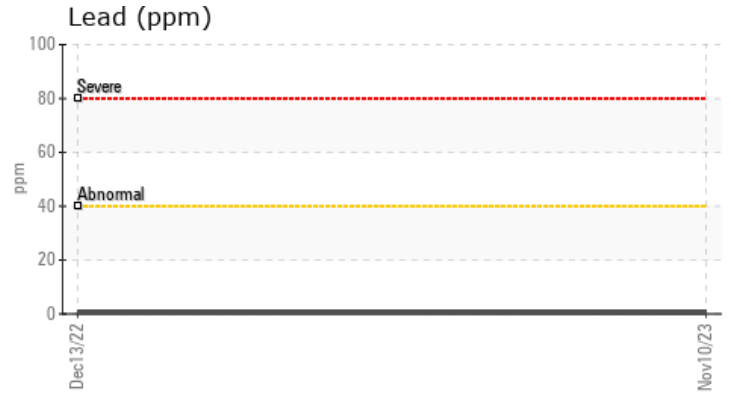
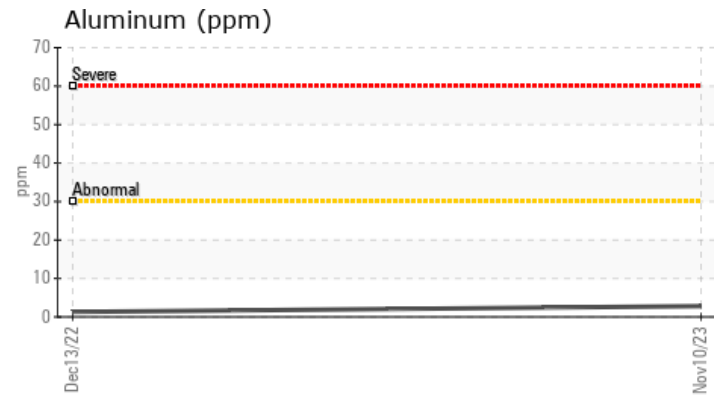
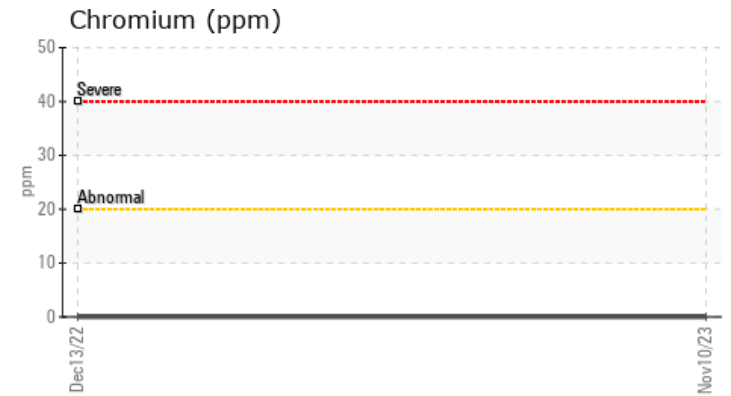
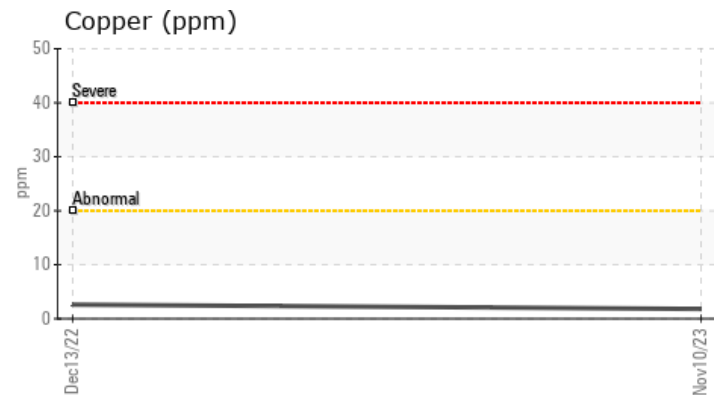
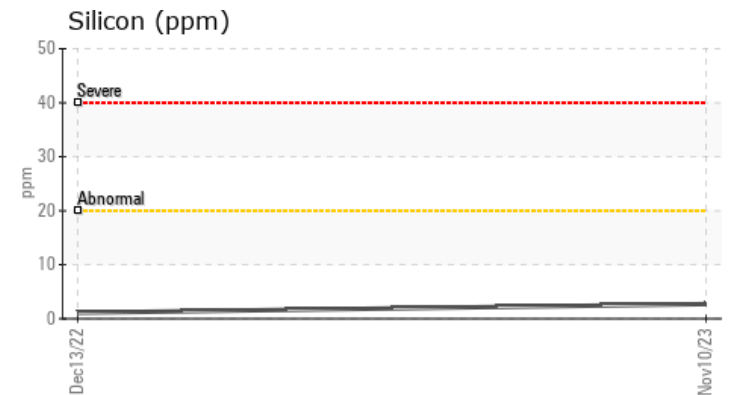
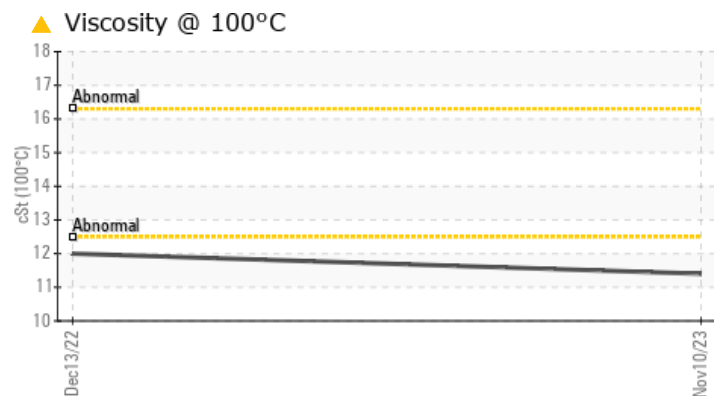
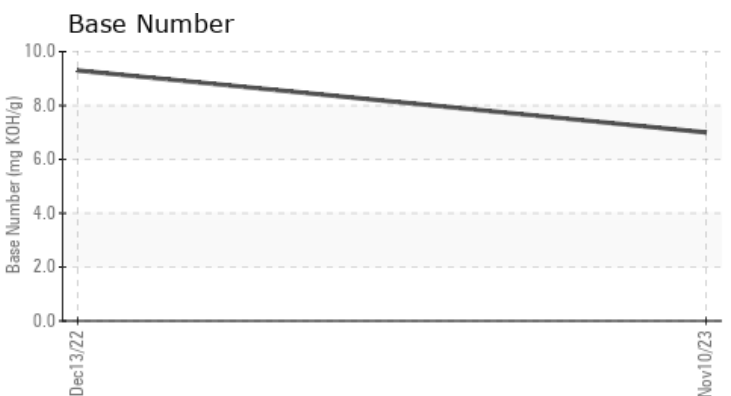
GRAPHS

The oil change at the time of sampling has been noted. We recommend an early resample to monitor this condition. All component wear rates are normal. There is a moderate amount of fuel present in the oil. Tests confirm the presence of fuel in the oil. The BN result indicates that there is suitable alkalinity remaining in the oil. Fuel is present in the oil and is lowering the viscosity. The oil is no longer serviceable due to the presence of contaminants.
