CONSTRUCTION EQUIPMENT

VOLVO L150H 4375 - TRANSMISSION (AUTO)

Sample No: VCP442917
Oil Type: MOBIL TRANS AST
Job No:

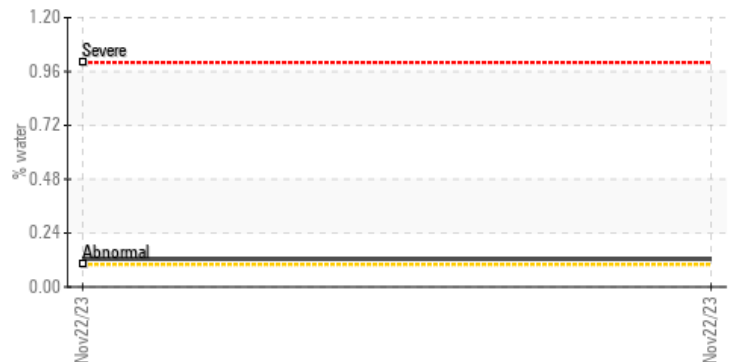
Water	%	0.125	NEG	NEG	NEG
Silicon	ppm	4	5	7	4
Sodium	ppm	2	3	2	1
Potassium	ppm	0	0	0	0

Resample at the next service interval to monitor. All component wear rates are normal. There is a light concentration of water present in the fluid. The condition of the fluid is acceptable for the time in service.
