CONSTRUCTION EQUIPMENT

A11510 VOLVO A30D 74082 - DIESEL ENGINE

Sample No: VCP431245
Oil Type: MOBIL 15W40
Job No: A11510

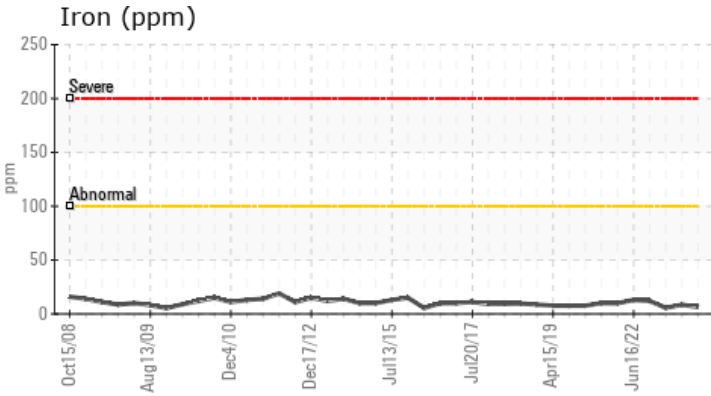
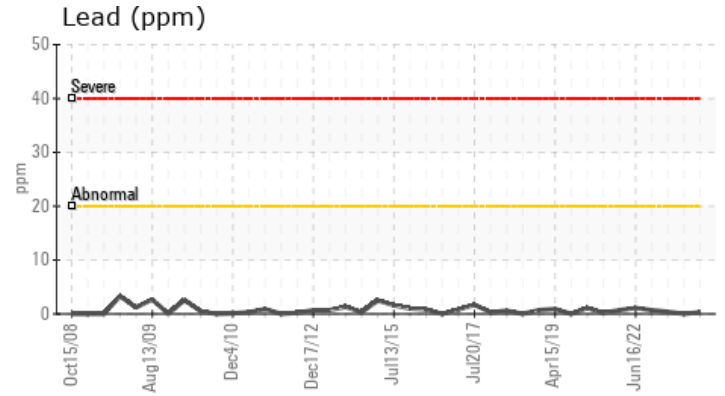
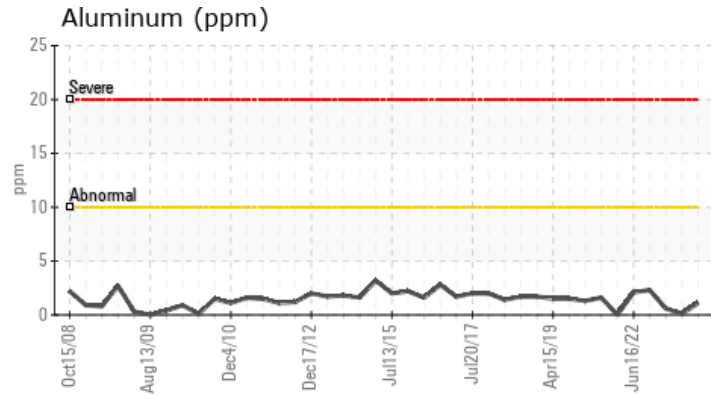
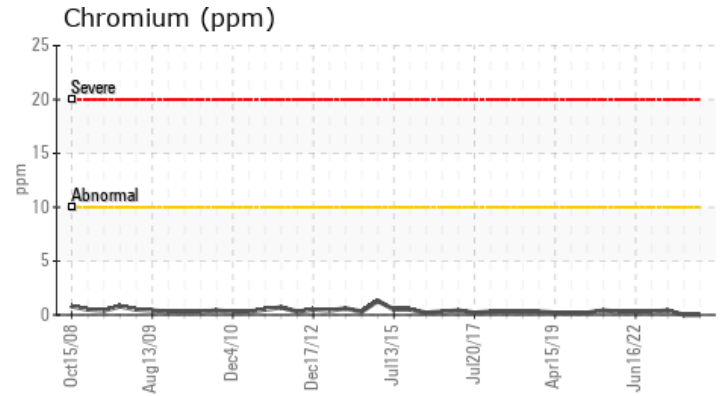
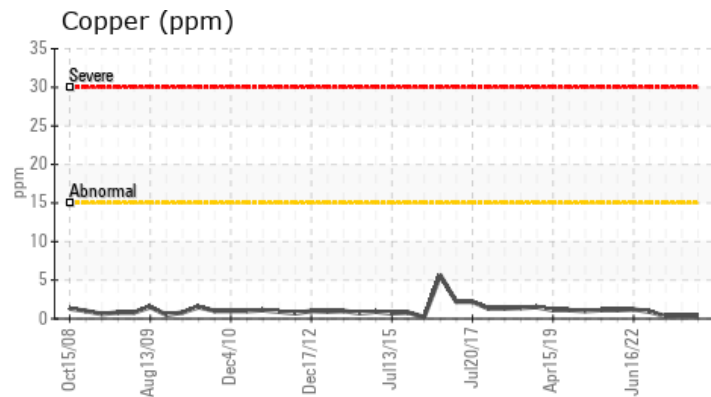
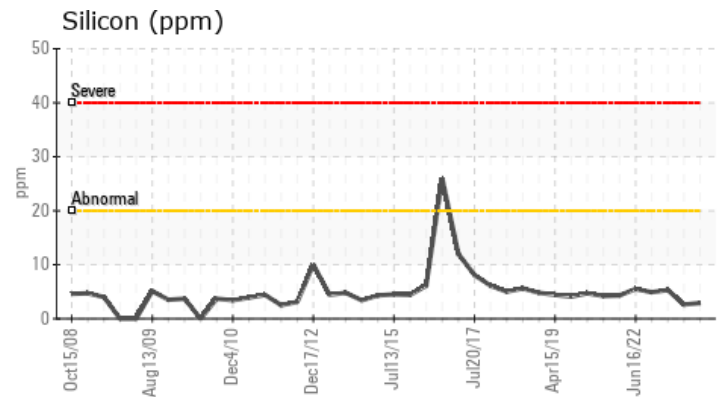
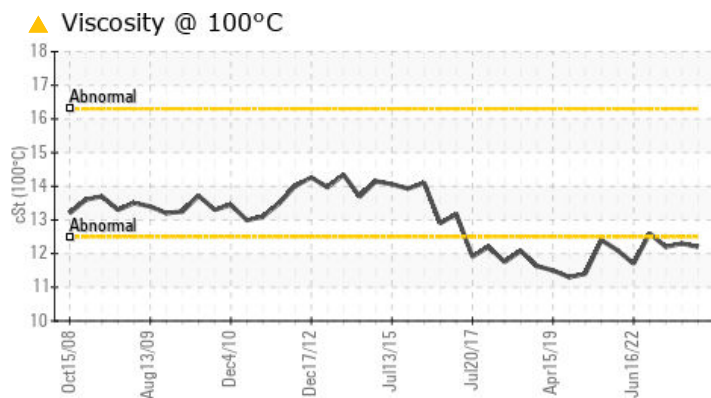
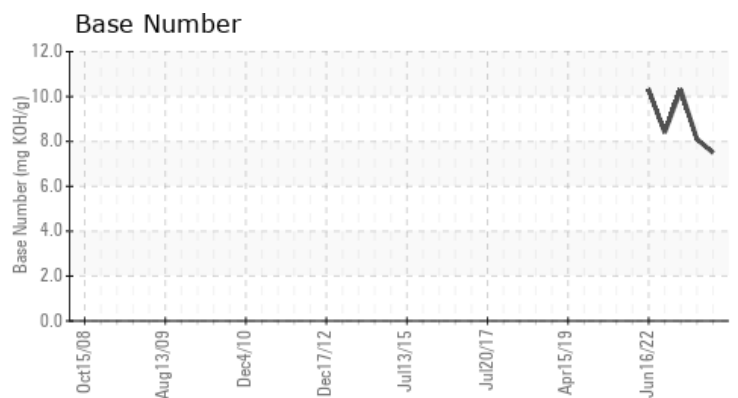
VOLVO GRAPHS

Diagnosis
Oil and filter change at the time of sampling has been noted. Resample at the next service interval to monitor. All component wear rates are normal. There is no indication of any contamination in the oil. The oil viscosity is lower than normal. The BN result indicates that there is suitable alkalinity remaining in the oil. Confirm oil type.
