CONSTRUCTION EQUIPMENT

2739-1 VOLVO L90F 3199 - TRANSMISSION (AUTO)

Sample No: VCP429487
Oil Type: VOLVO AUTOMATIC TRANSMISSION FLUID AT102
Job No: 2739-1

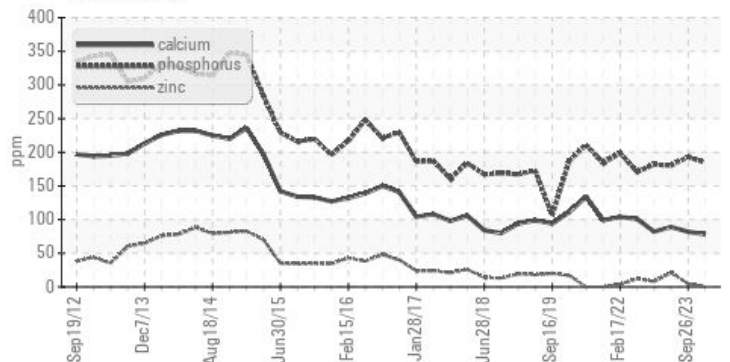
Additives

Calcium	ppm	78	82	89	82
Magnesium	ppm	0	2	5	4
Zinc	ppm	0	5	21	8
Phosphorus	ppm	185	193	180	182
Barium	ppm	0	0	0	0
Boron	ppm	89	97	89	101
