CONSTRUCTION EQUIPMENT

660034 VOLVO L110H 631294 - TRANSMISSION (AUTO)

Sample No: VCP452336
Oil Type: VOLVO AT 102
Job No: 660034

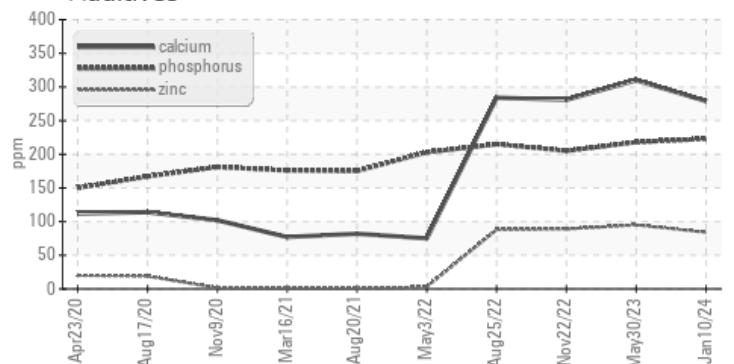
Additives

Calcium	ppm	279	310	281	284
Magnesium	ppm	17	18	18	15
Zinc	ppm	84	95	89	88
Phosphorus	ppm	223	218	205	215
Barium	ppm	0	0	0	1
Boron	ppm	73	79	72	100
