CONSTRUCTION EQUIPMENT

VOLVO A30G 752143 - BRAKE COOLING SYSTEM

Sample No: VCP454173
Oil Type: DIESEL ENGINE OIL SAE 15W40
Job No:

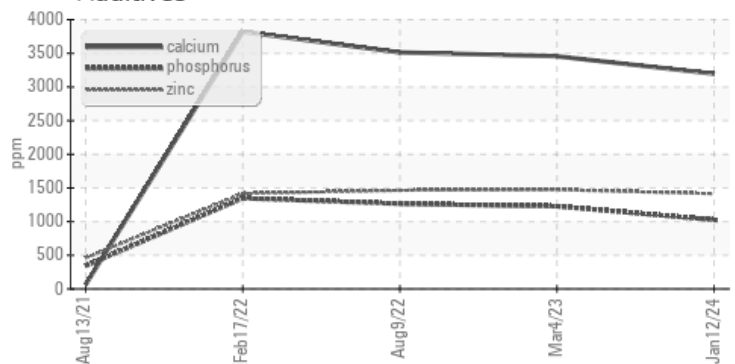
Additives

Calcium	ppm	3196	3456	3513	3820
Magnesium	ppm	9	11	6	7
Zinc	ppm	1414	1473	1464	1417
Phosphorus	ppm	1026	1227	1264	1347
Barium	ppm	6	0	0	0
Boron	ppm	108	104	128	114
