CONSTRUCTION EQUIPMENT

X59196 VOLVO SDLG L959F 640017 - FRONT RIGHT FINAL DRIVE

Sample No: VCP440826
Oil Type: {unknown}
Job No: X59196

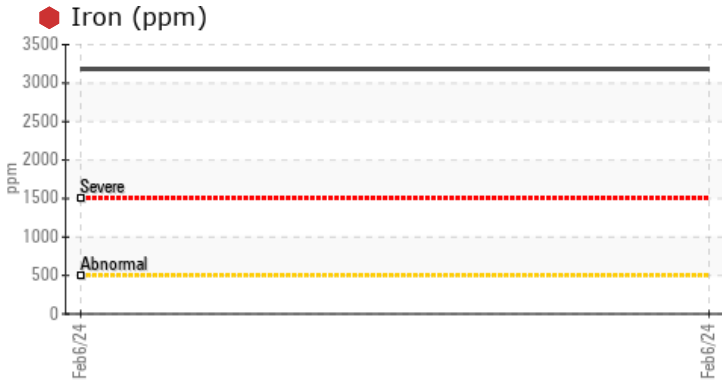
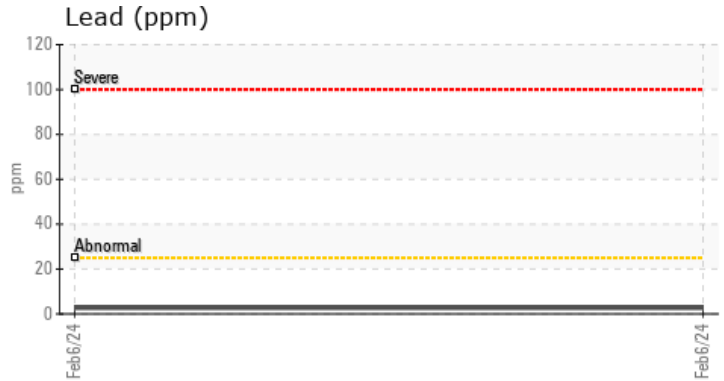
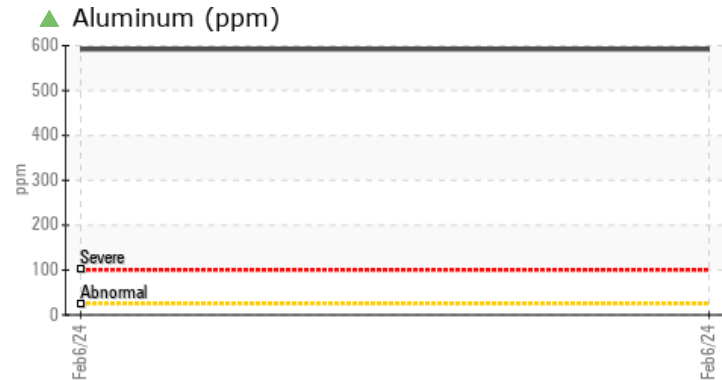
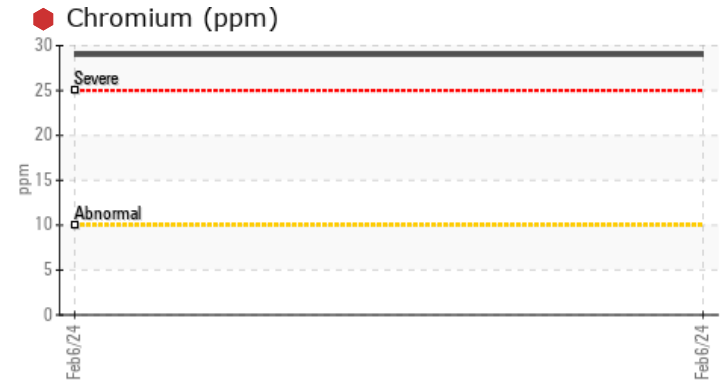
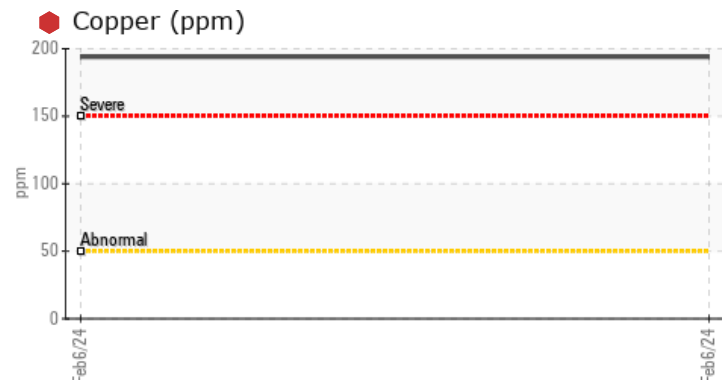
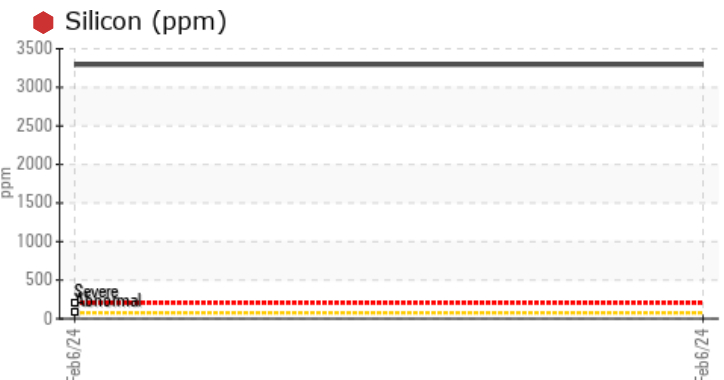
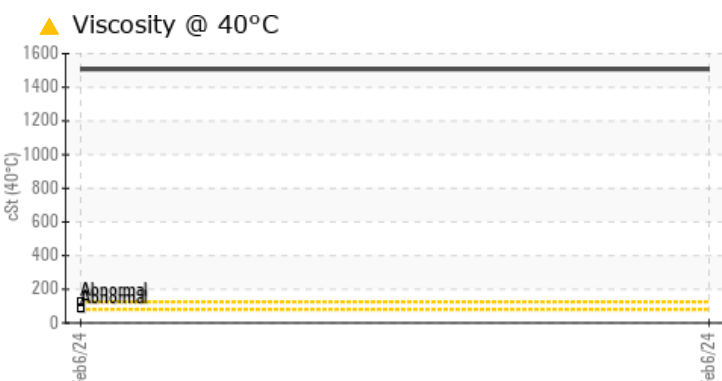
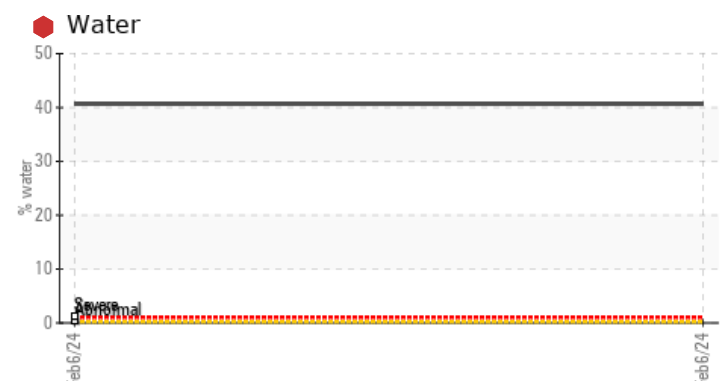
VOLVO **GRAPHS**

Visc @ 40°C	cSt	▲ 1508	---	---	---
-------------	-----	--------	-----	-----	-----

Water	%	◆ 40.7	---	---	---
Silicon	ppm	◆ 3294	---	---	---
Sodium	ppm	■ 29	---	---	---
Potassium	ppm	■ 66	---	---	---

Iron	ppm	◆ 3184	---	---	---
Copper	ppm	◆ 194	---	---	---
Lead	ppm	■ 3	---	---	---
Tin	ppm	▲ 22	---	---	---
Aluminum	ppm	▲ 592	---	---	---
Chromium	ppm	◆ 29	---	---	---
Molybdenum	ppm	0	---	---	---
Nickel	ppm	■ 1	---	---	---
Titanium	ppm	■ 40	---	---	---
Silver	ppm	0	---	---	---
Manganese	ppm	31	---	---	---
Vanadium	ppm	2	---	---	---

We advise that you check for the source of water entry. We advise that you check all areas where dirt can enter the system. We recommend that you drain the oil from the component if this has not already been done. We advise that you inspect for the source(s) of wear. Please note that there was too much water present in the oil to perform a viscosity test. Bearing and/or gear wear is indicated. Appearance is unacceptable. There is a high concentration of water present in the oil. Elemental levels of silicon (Si) and aluminum (Al) indicate alumina-silicate (coarse dirt) ingress. The oil is no longer serviceable due to the presence of contaminants.
