CONSTRUCTION EQUIPMENT

W0229973 VOLVO EC280E 316085 - DIESEL ENGINE

Sample No: VCP428606
Oil Type: DIESEL ENGINE OIL SAE 15W40
Job No: W0229973

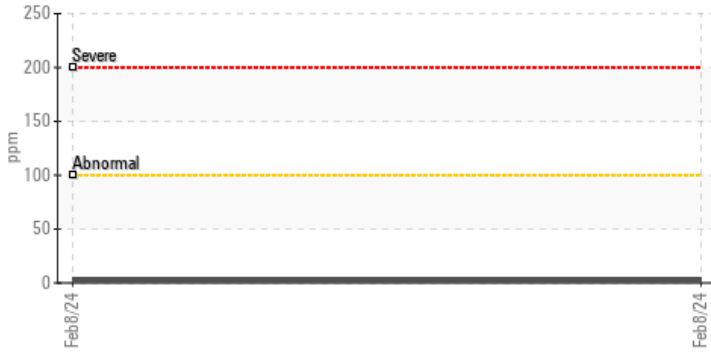
Iron (ppm)

Iron	ppm	█ 2	---	---	---
Copper	ppm	█ <1	---	---	---
Lead	ppm	█ 0	---	---	---
Tin	ppm	█ 0	---	---	---
Aluminum	ppm	█ 5	---	---	---
Chromium	ppm	█ <1	---	---	---
Molybdenum	ppm	█ 111	---	---	---
Nickel	ppm	█ 0	---	---	---
Titanium	ppm	█ 2	---	---	---
Silver	ppm	█ 0	---	---	---
Manganese	ppm	█ 0	---	---	---
Vanadium	ppm	<1	---	---	---

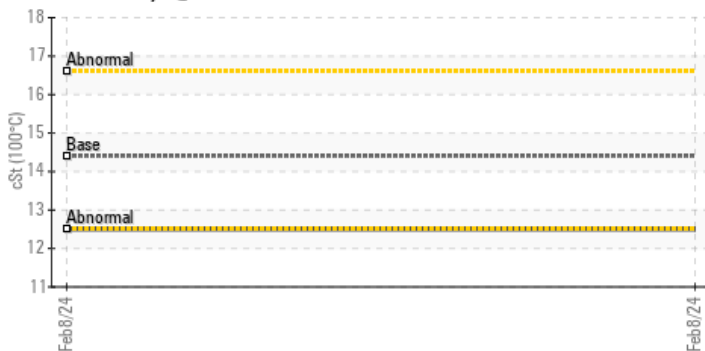
Viscosity @ 100°C

Visc @ 100°C	cSt	█ 12.5	---	---	---
Base Number (BN)	mg KOH/g	█ 9.1	---	---	---
Oxidation (PA)	%	61	---	---	---

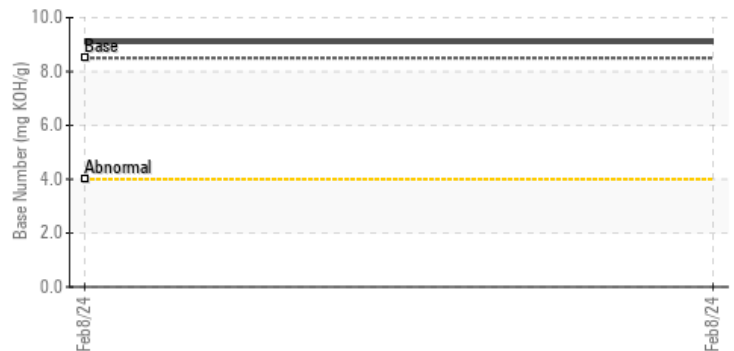
Base Number

Resample at the next service interval to monitor. All component wear rates are normal. There is no indication of any contamination in the oil. The BN result indicates that there is suitable alkalinity remaining in the oil. The condition of the oil is suitable for further service.
