660406 VOLVO L150H 6059 - TRANSMISSION (AUTO)

Sample No: VCP440028
Oil Type: VOLVO AUTOMATIC TRANSMISSION FLUID AT102
Job No: 660406

SAMPLE INFORMATION

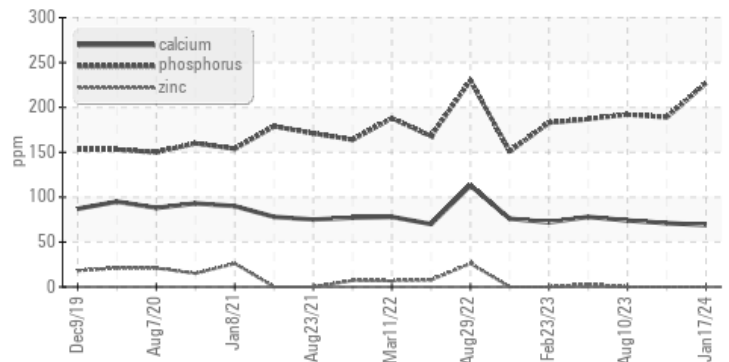
Additives

Calcium	ppm	69	71	74	78
Magnesium	ppm	<1	1	0	<1
Zinc	ppm	0	0	0	3
Phosphorus	ppm	227	189	192	187
Barium	ppm	10	0	0	0
Boron	ppm	73	79	89	93
