CONSTRUCTION EQUIPMENT

2825-1 VOLVO L90F 3199 - TRANSMISSION (AUTO)

Sample No: VCP445922
Oil Type: VOLVO AUTOMATIC TRANSMISSION FLUID AT102
Job No: 2825-1

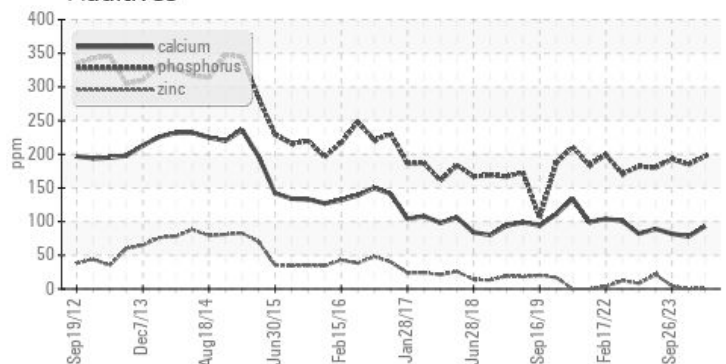
Additives

Calcium	ppm	93	78	82	89
Magnesium	ppm	<1	0	2	5
Zinc	ppm	2	0	5	21
Phosphorus	ppm	197	185	193	180
Barium	ppm	0	0	0	0
Boron	ppm	82	89	97	89
