CONSTRUCTION EQUIPMENT

SHOP VOLVO L120G 30056 - DIESEL ENGINE

Sample No: VCP425537
Oil Type: PETRO CANADA 10W30
Job No: SHOP

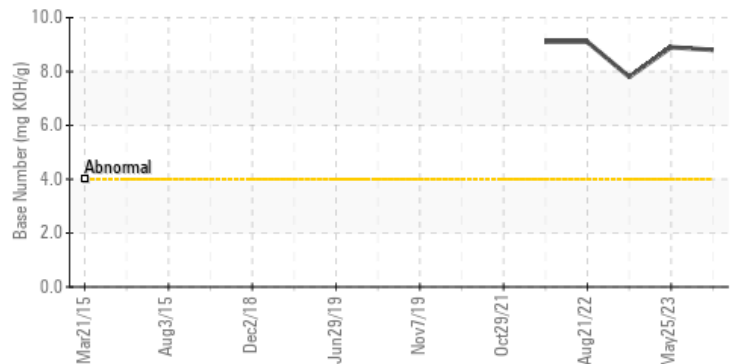
Visc @ 100°C	cSt	11.4	11.3	11.6	10.4
Base Number (BN)	mg KOH/g	8.8	8.9	7.8	9.1
Oxidation (PA)	%	57	53	62	67

Resample at the next service interval to monitor. All component wear rates are normal. There is no indication of any contamination in the oil. The BN result indicates that there is suitable alkalinity remaining in the oil. The condition of the oil is suitable for further service.
